Water Ingress in Building Basement Eliminated with Acrylic Gel

Underground Basement

Wollongong, NSW,
Australia

1 week / February 2020

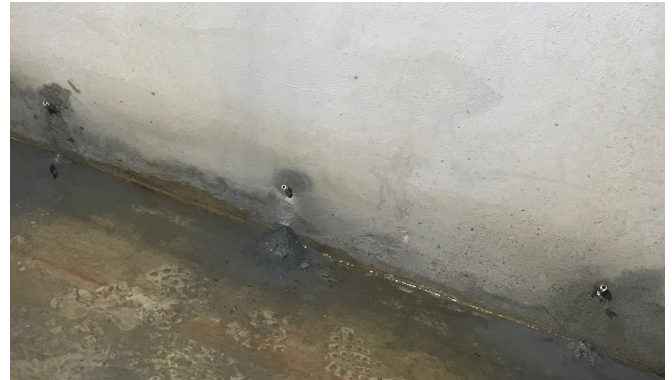
Injection points across basement walls

Mainmark injected a specially formulated acrylic gel to areas where leaking was evident. The acrylic-based hydro-structural resin was identified as the most appropriate solution due to the product's ability to track the exact path of the water source, seal using a controllable reaction time, and ultra-low viscosity to seal behind the blind sides of the basement walls.

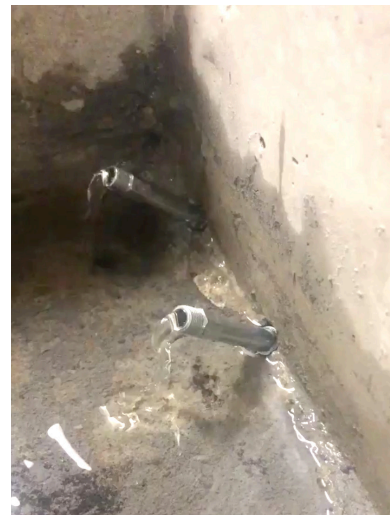
Mainmark's team was able to locate the source of the water, which was found to be leaking through the combination secant piled and shotcrete wall system and the basement slab. They were then able to successfully deliver a perimeter treatment that intersected the interface between the wall system and the middle of the concrete slab.

Water leakage through basement staircase before injection

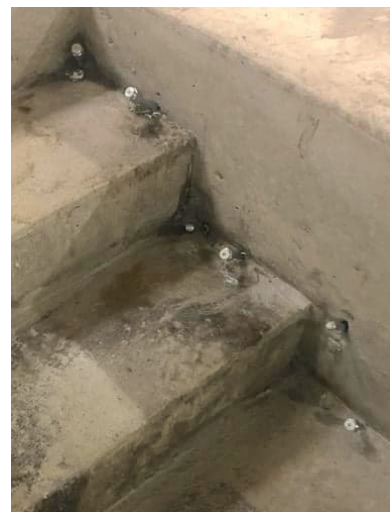
Water leakage through basement staircase after injection
