Large Swimming Pool Re-levelled

Pool

Sinking pool

QLD, Australia

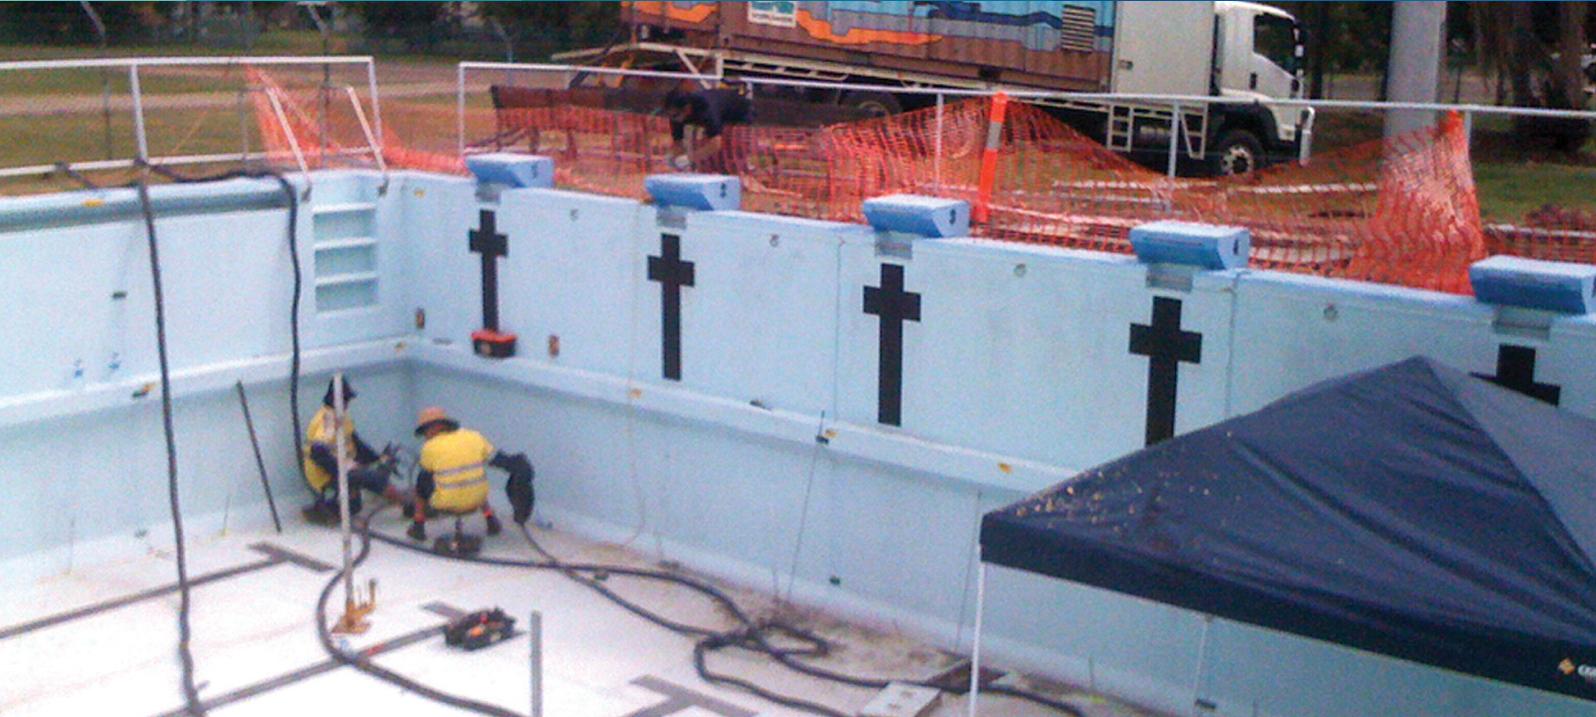
Above: Ten days in the blazing Queensland sun made a sun-shielding tent a necessity! An excellent result made it worthwhile!
