Heritage Building Re-levelled

Earthquake remediation

Kaiapoi, New Zealand

Mainmark New Zealand

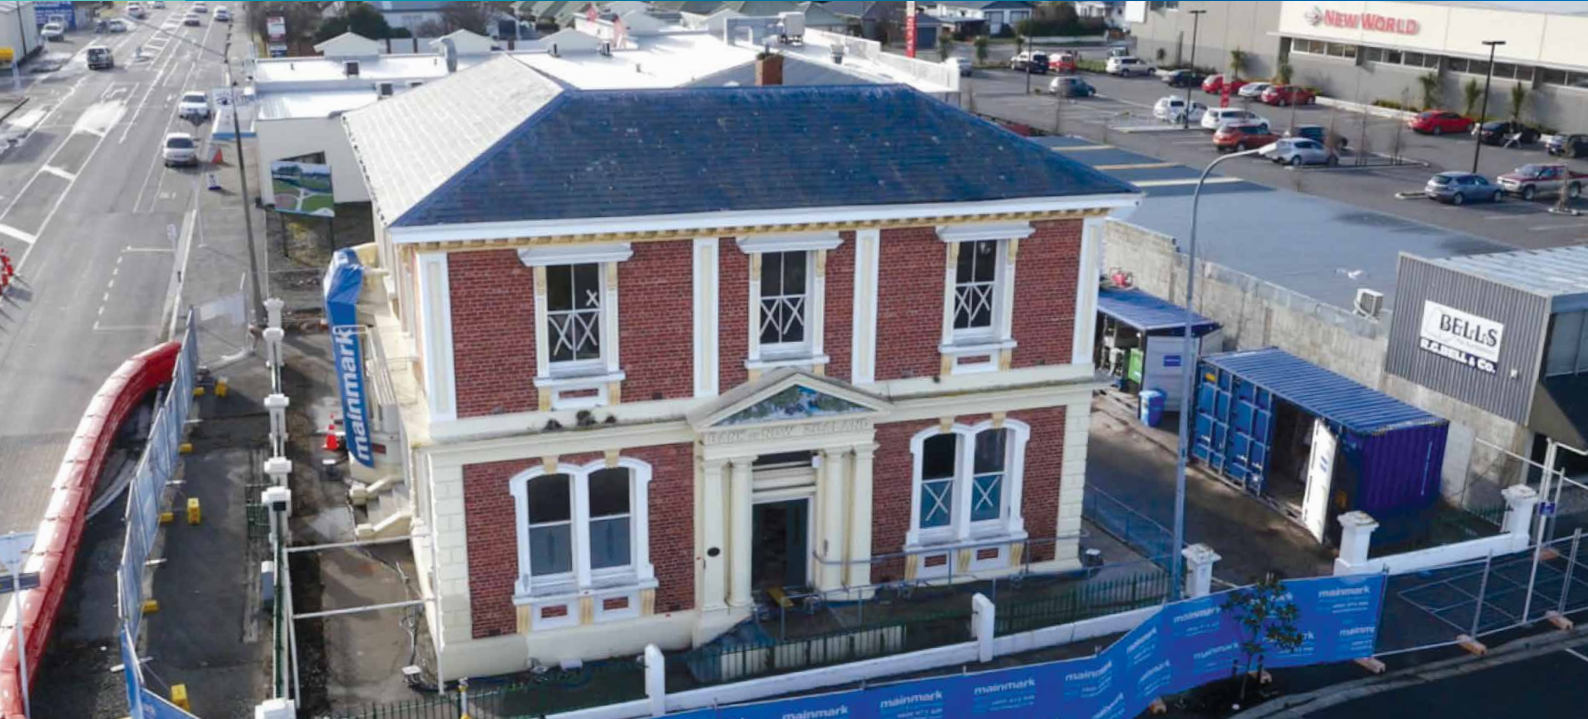
Above: Earthquakes resulted in substantial damage to this Category One Heritage listed building in Kaiapoi, New Zealand.

This 130-year old building suffered significant damage in the earthquakes that hit New Zealand's South Island in 2010 and 2011. A well known Kaiapoi landmark, the old Bank of New Zealand building was built in 1833. As a Category One Heritage New Zealand listed building, it was important to the owner, local council and the local community that the building be repaired and restored.

The 250-tonne building had subsided across the entire footprint towards the North East corner by more than 200mm.

JOG computer-controlled grouting was used on the project. JOG is a non-invasive method, delivering a highly controlled, precise and gentle lift.

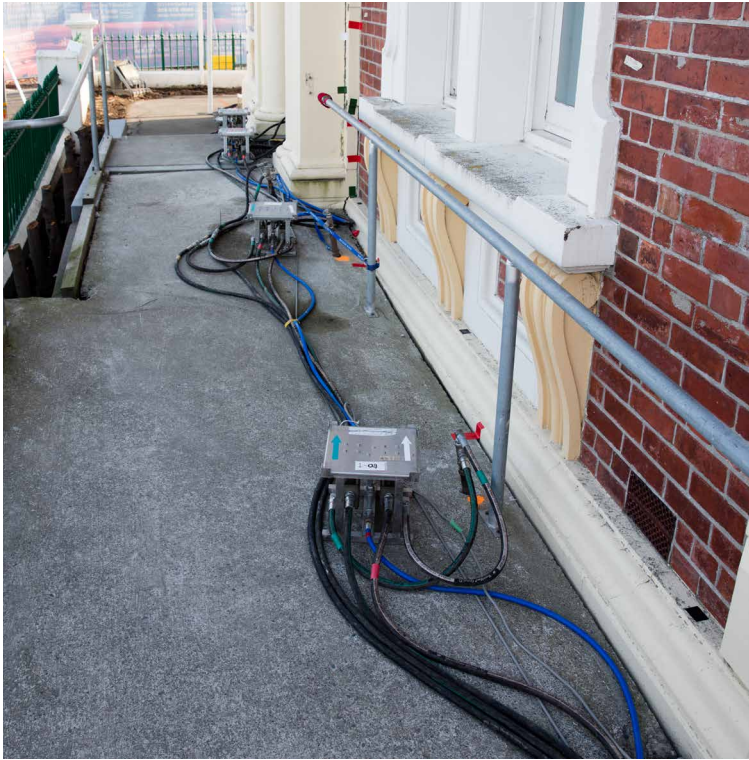
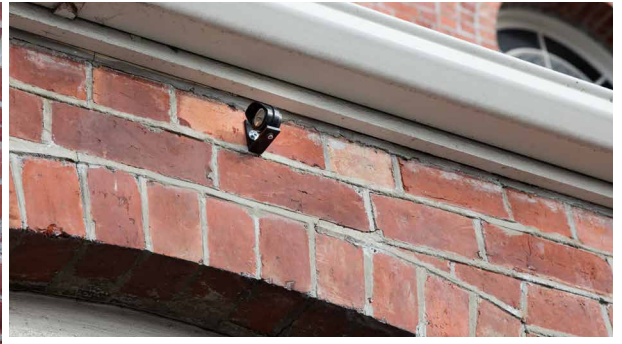
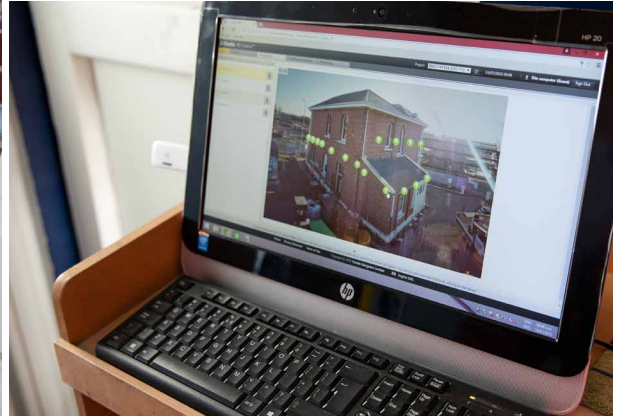
Above: JOG androids were placed at pre-determined, strategic points, internally and externally. Use of this non-invasive technology meant any further, significant damage to the heritage building was avoided.

The building's construction, current condition and the degree of lift required were all considerations in the design of the injection array. One hundred 40mm diameter injectors were installed beneath the perimeter and internal foundations of the building, including the existing bank safe. There was minimal impact to the historic floors, which meant they did not need to be removed.

Lifting was gentle, uniform and gradual, protecting the fragile nature of the building. Continuous surveying, internally and externally, was delivered via a fully automated Trimble monitoring system and manual assessment. The high degree of monitoring was a key contributor in achieving such an accurate and precise outcome.

Remediation and re-levelling was entirely successful, delivering a sound base for the building's footings and restoring the building back to level. The non-invasive method applied ensured no further significant damage or consequent costs, allowing the restoration of the project to continue as planned.
