Power Station Floor Re-supported

Power Station

Ground Subsidence

Uretek Deep Injection

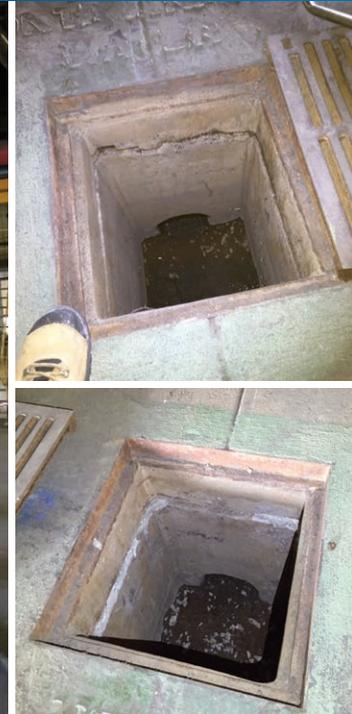
Boroscope inspections through the holes revealed a large amount of fill material had been washed out. Substantial cracks had opened up both between cooling water circulation channel inspection pits and the underside of the floor.

Above, right: Gaps between water circulation system inspection pits and the floor slabs were sealed by sub-floor injections of structural resins.

Uretek Deep-Injection of expanding structural resin was carried out across the affected area via tubes through the concrete floor at 2m to 3m centres. Injection was continued until full re-support of all sections of the floor was confirmed and until resin was observed to have sealed all cracks that had opened in the cooling water system inspection pits.
