High School Raised and Re-supported

School building

Yanco, NSW, Australia

Uretek Slab Lifting &
Uretek Deep Injection

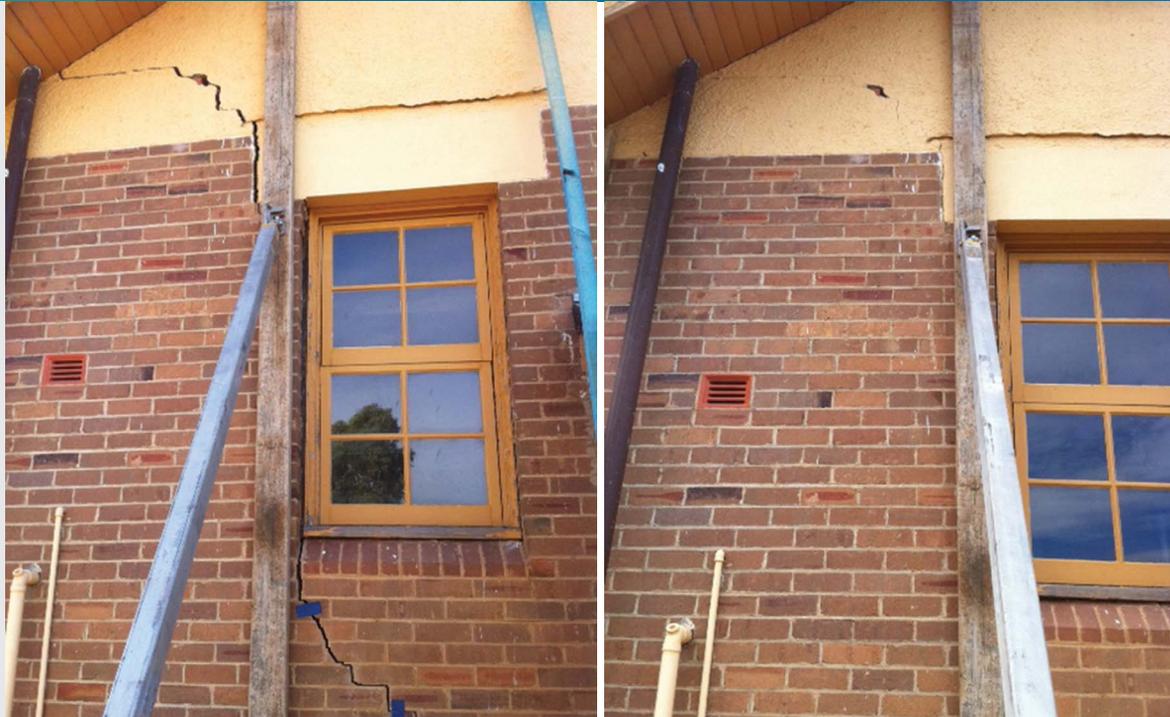
At the famous Yanco Agricultural High School building in Southern NSW the footings of the main meeting hall building had sunk into the ground due to drought causing shrinkage of reactive clay soil. Severe wall cracking had occurred. 12 swimming pool surround slabs had also sunk. The large Uretek Deep-Lifting project was completed in just one and a half days, with wall cracks closed and trip hazards eliminated.

Some of the wall cracking was 42 mm wide. But the crack closure was complete and the walls and the pool slabs were raised right back to where they had been originally.

Above, left: Wall cracking was up to 42 mm wide.
Above, right: Cracks completely closed as the wall footings were raised.

Uretek resins were injected through small diameter tubes. As the resins went into the ground, they expanded. The ground was compacted and voids were filled.

Continued injection and expansion of the resins, constantly monitored by laser levels, produced the power to lift and re-level the heavy structure.

To ensure that the lifting rotated the walls back into place with absolute accuracy, the Joss team put Acro props against the top of the walls.
