Specialty Coatings Refurbish Drinking Water Reservoir in Far North Queensland

PROJECT PROFILE

Q15W053

Above ground reservoir

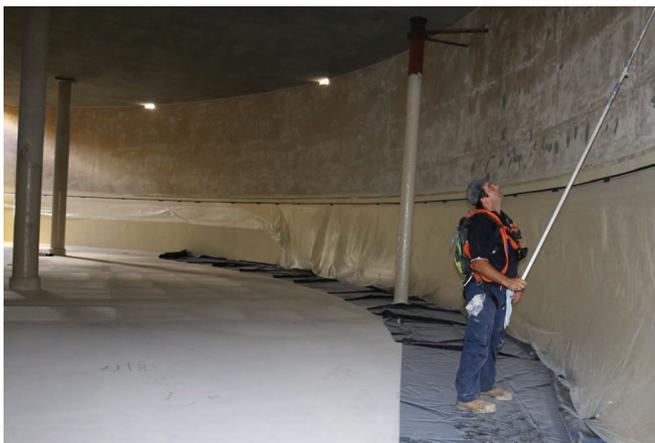
Mainmark technician applying polyurea product on the wall of the water tank

The original tender called for an epoxy coating system for the internal surfaces of the reservoir. Mainmark proposed the alternate pure polyurea product, which was better suited for this specific application. The selected coating features more than 400% elongation to allow for structural movement and cracks in the substrate, and offers high abrasion and corrosion resistance as well as exceptional adhesion, providing long-term protection of the asset.

Importantly, the chosen polyurea has a long and successful history of safely protecting the inside of many concrete and steel drinking water municipal reservoirs throughout Australia. When used in conjunction with an epoxy primer, the Australian made coating is certified safe for contact with drinking water to AS4020-2005.

Mainmark sprayed a 3mm layer of the protective coating system onto the internal surfaces of the reservoir. The external surfaces were then finished with a high performance anti-graffiti epoxy coating system suitable for the conditions around the location.
