Mainmark Develops Bespoke Solution to Stabilise Underground Mine Crusher

PROJECT PROFILE

N17A099

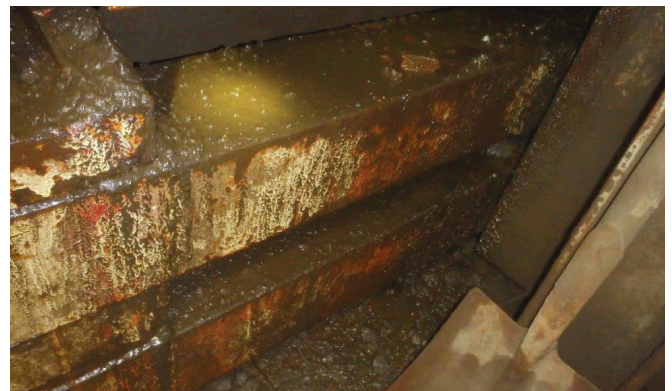
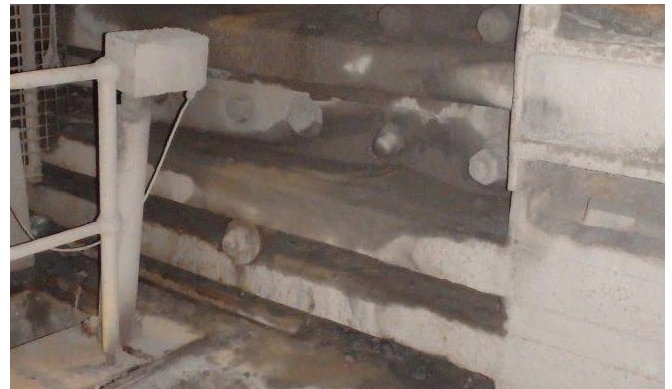
The oil bath surrounding the crusher needed to be removed before Mainmark solution could be applied

High-pressure water and detergent systems were used to prepare the surfaces and remove the oil bath surrounding the crusher, ahead of the placement of the chosen grout systems. The crusher was also stripped down to enable access to the treatment area.
