Terefil® Used to Abandon Pipeline at Iron Mine

Tailing Dam Drain Pipes

Pipe Decommissioning

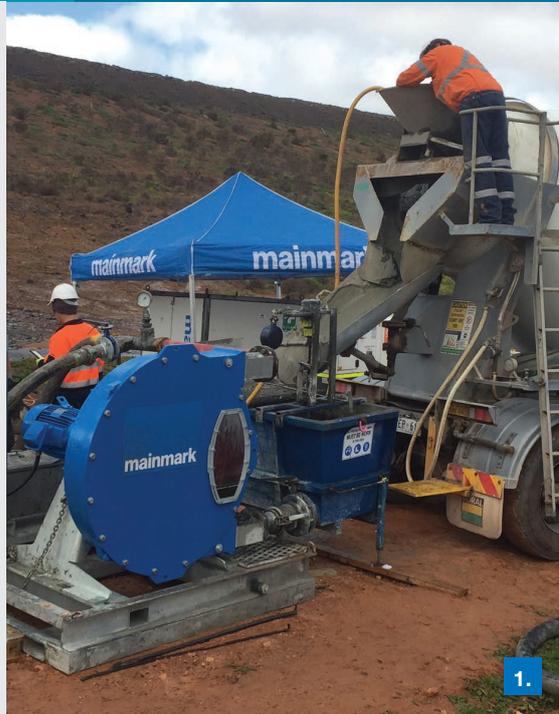
Pictured: 1. Mainmark pump zone of operations. 2. Single access point to pipe for abandonment.
