# Gladstone Steel Drain Refurbishment

230m x 1.8m Steel Pipe

Steel Pipe Corrosion

ENCAP6™

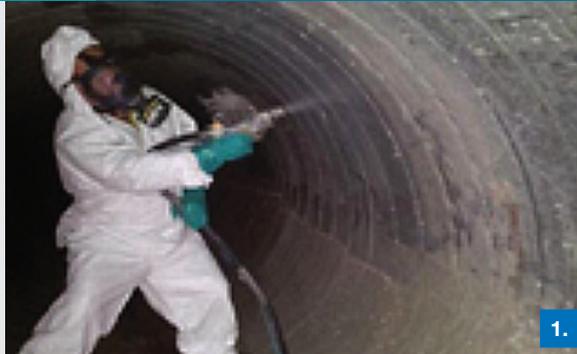
Right: 1. Test spraying.  
2, 3, 4: Coating on bottom of the pipe completed.

- A feasibility study: Newcastle University handled the finite element analysis to calculate the loads and overall strength of the ENCAP6™ reinforced pipe.
- Injecting structural expanding resin behind the pipe structure into holes drilled through the pipe every 50cm (all around the pipe) to realign the entire length, remediate the soil and structurally support the pipe.
- Re-filling the washed out areas at the base of the pipe, which had been eroded, with fast setting cement.
- Coating the base of the pipe with a 12mm layer of glass reinforced ENCAP6-950 fabric laminate.
- Spraying a 16mm layer of ENCAP6-950 onto the sides and roof of the pipe.
