Stabilising a retaining wall with Teretek®

Sea wall

Sydney, NSW, Australia

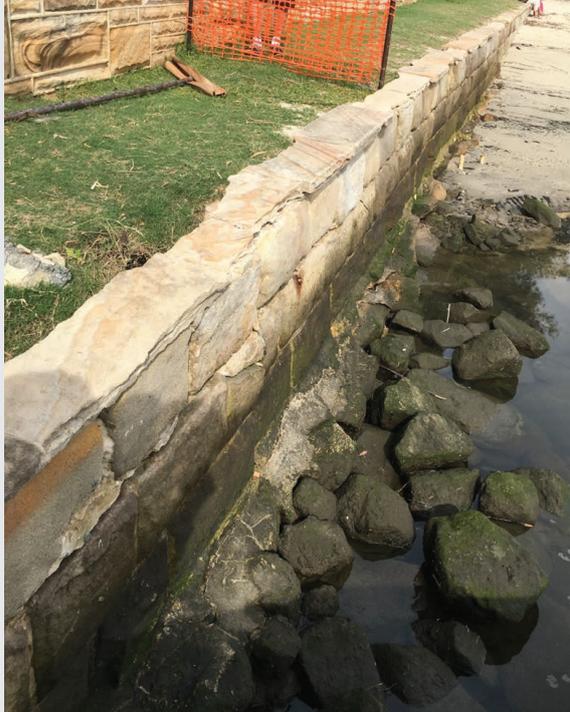
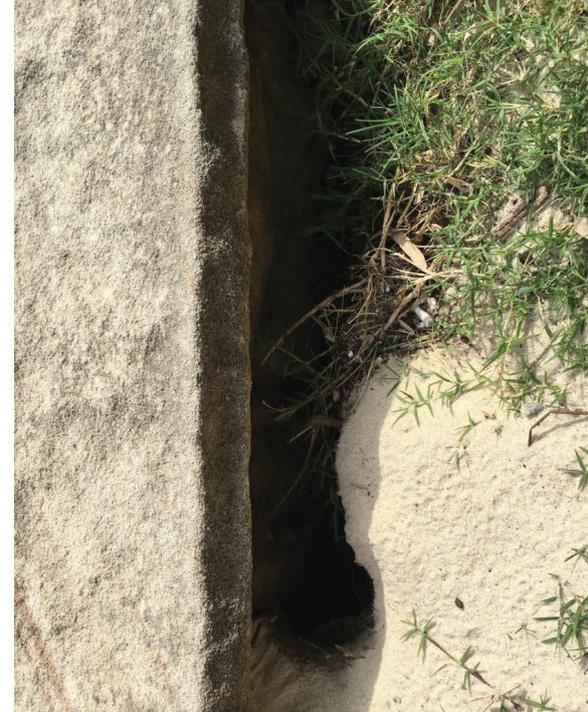
The sandstone sea wall protecting the lawn and swimming pool area of a prestigious, beachside apartment complex in Sydney had begun to erode, causing sinkholes to form in the lawn area. Left unchecked, there was a risk that the subsidence could spread towards the building itself, leading to structural instability.

In a process similar to keyhole surgery, Mainmark technicians drilled a number of injection points at 500mm under the sea wall to a depth of 2,500mm before injecting the Teretek® expanding polyurethane resin mix through very small injector tubes. The components mix together and expand, strengthening the ground and re-levelling the wall quickly and with minimal disruption.

After initial success with the microfine Permeation Grouting, Mainmark's technicians discovered that some of the site material was non-permeable. After consultation with the client's engineer, Mainmark proposed using their Teretek® resin injection solution to complete the consolidation of the fill material and help protect the sea wall from further erosion.
