Rail Track Void-filled and Re-levelled

Sinking rail

Kaimai, New Zealand

Uretek Slab Lifting &
Uretek Deep Injection

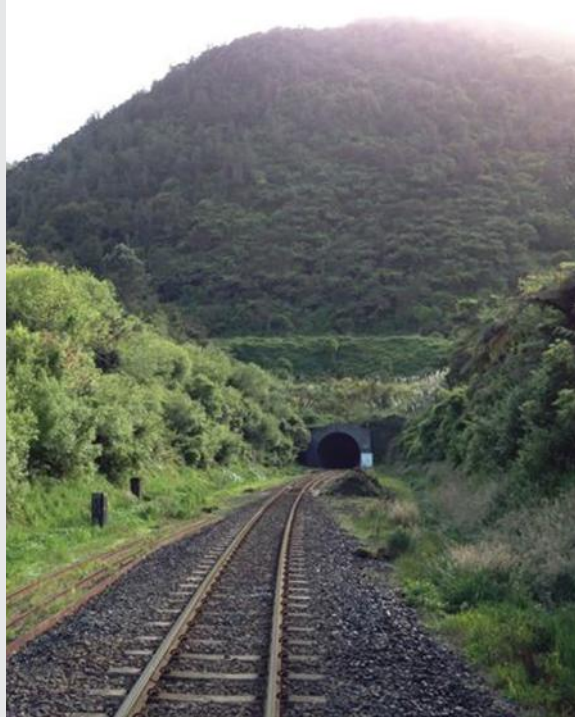
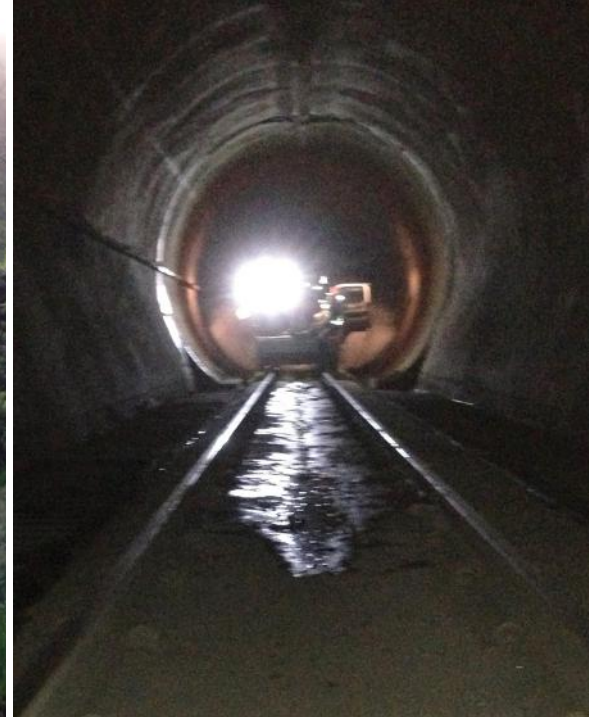
In the Kaimai tunnel in New Zealand a section of rail slab base had subsided up to 50mm overall, where the underlying rock beneath the rail slab base had been crushed by the overburden weight of the trains running over (40 ton minimum weight).

Subsequently natural water ingress, with drains on either side of the track, had eroded away the rail base over time, leaving a large void, around 300mm deep, beneath the track.

Deep-Injection of engineered structural resin was applied to fill the voids. That displaced the water; and then Uretek resin was injected in an exactly controlled

manner until each line was raised back to its original level. In order to achieve the required degree of precision the process was constantly monitored by laser leveller.

The rail was lifted up to +5mm of the original level. The one day job was completed at 5.15pm and the first freight train ran across the rail at 6.30pm. Kiwi Rail had movement monitoring devices set up alongside the treated section, and there was no movement at all.
