Stacker Crane Rail Re-levelled

Stacker-Reclaimer Rail

Sinking Rail

Uretek Slab Lifting & Uretek Deep Injection

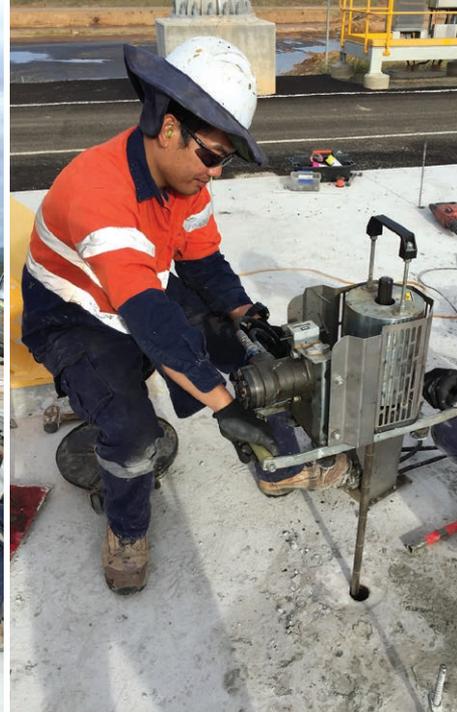
Far right: Pneumatic DCP testing to determine injection depths.

Geotechnical investigation via DCP and seismic testing indicated soft spots in the ground from two metres to six metres deep.

Commissioned by the site engineers, Mainmark treated a section approximately 15 metres either side of the slab joint. Expanding structural resin was injected under the rail beam at depths of 2.5, 3.5 and 4.5 metres, as had been determined by pneumatic DCP tests. Injections were made through the centre of the rail beam, at either edge of the three metre wide beam and at one metre centres along the beam.
