Embankment stabilisation using Permeation Grouting

As part of a rail upgrade project in Western Australia, to improve urban transport links, an unstable soil embankment needed to be consolidated to allow safe excavation within a railway corridor.

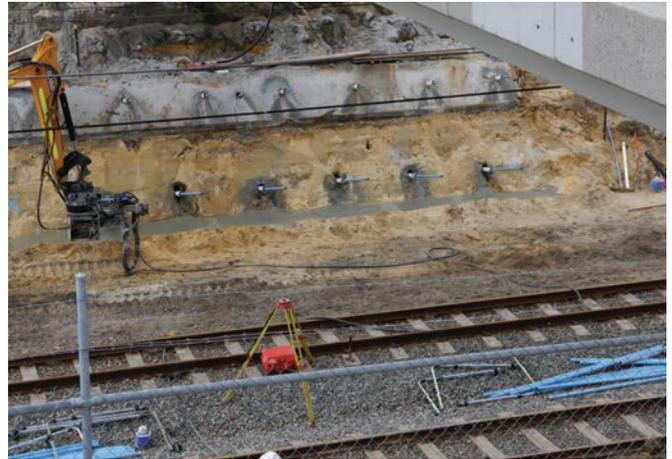
Installation of 9m deep Hollow Bar Soil Nails

Following treatment, the overburden would be removed and the embankment could be cut and shaped. Mainmark then installed 9m Hollow Bar Soil Nails in a grid pattern, installed drainage, covered it with mesh and then applied shotcrete to the area to a minimum 150mm thickness at 32 MPa.

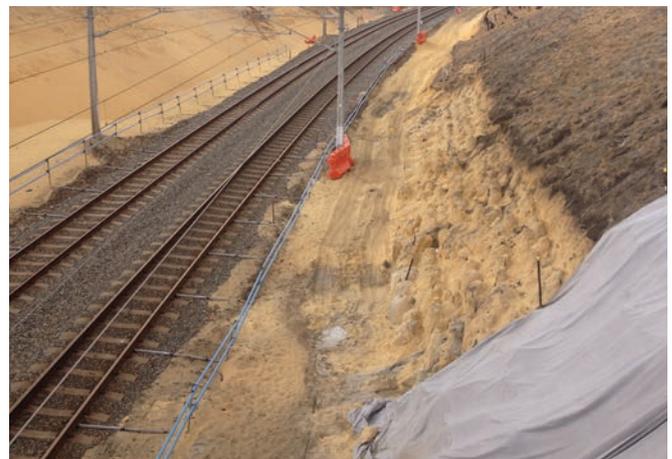
The slope after Permeation treatment and initial cut

Mainmark treated the soil by inserting permeation tubes through 3.5m of overburden to an additional 2.5m of depth into the treatment area. As a result, it was necessary to perform a complete and continual levels and layout survey.
