Teretek® fills voids and strengthens ground under a Paraparaumu Beach home

PROJECT PROFILE

Z18W030

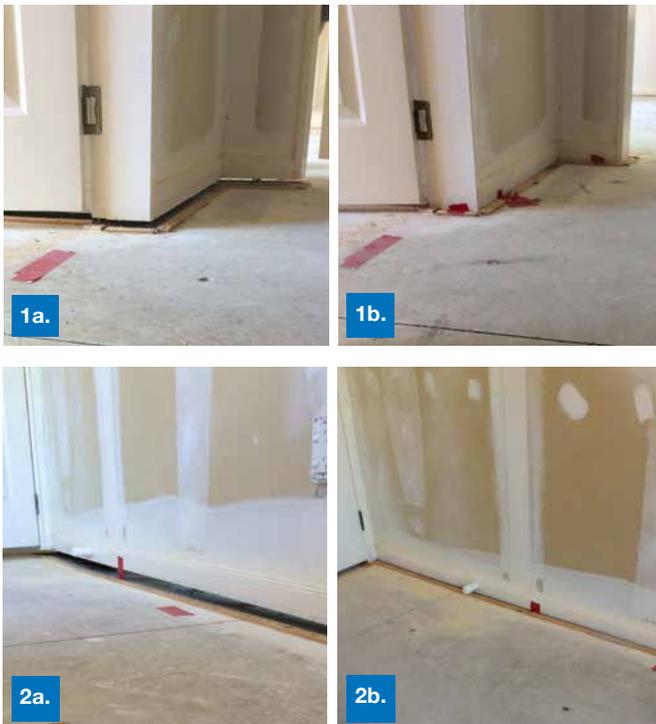
1a, 2a: Before and 1b, 2b: After Teretek® engineered resin being injected

Mainmark used its proprietary engineered resin injection solution, Teretek®, which provides a two-in-one benefit. As well as filling voids and strengthening foundation ground, Teretek also lifts and re-supports load bearing structures.

The home now sits on solid ground, the cracks have closed and the doors and windows have come back into alignment. The homeowner was amazed to see how the slab came up to meet the bottom plate of the walls when the resin was injected.
