Teretek® Fills Voids and Strengthens Ground Under a Paraparaumu Beach Home

PROJECT PROFILE

Z18W030

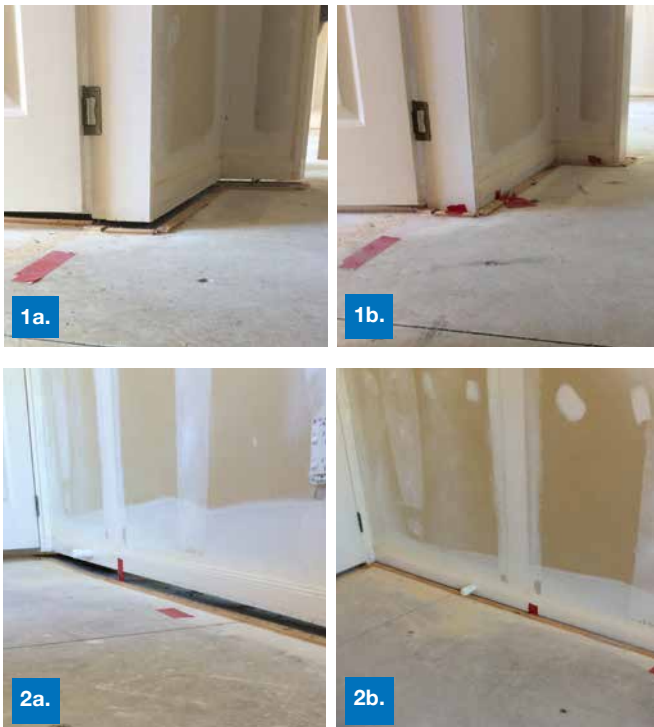
1a, 2a: Before and 1b, 2b: After Teretek® engineered resin being injected

Mainmark used its proprietary engineered resin injection solution, Teretek®, which provides a two-in-one benefit. As well as filling voids and strengthening foundation ground, Teretek also lifts and re-supports load bearing structures.

The home now sits on solid ground, the cracks have closed and the doors and windows have come back into alignment. The homeowner was amazed to see how the slab came up to meet the bottom plate of the walls when the resin was injected.
