# Teretek® Fills Underwater Voids to Stabilise Kimberley Rail Bridge Piers Following Floods

PROJECT PROFILE

T18E001

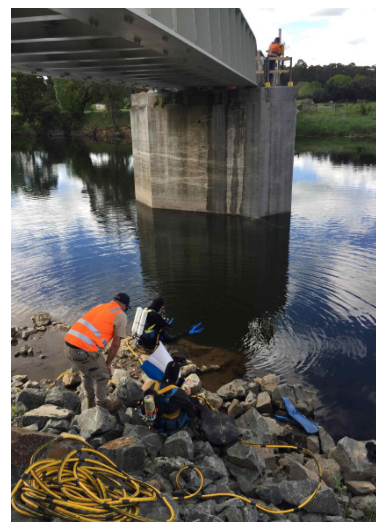
Divers preparing to inspect scour
