# Permeation Grouting Used to Strengthen Sand-Based Foundations at Coogee Beach Residence

PROJECT PROFILE

N20GW027

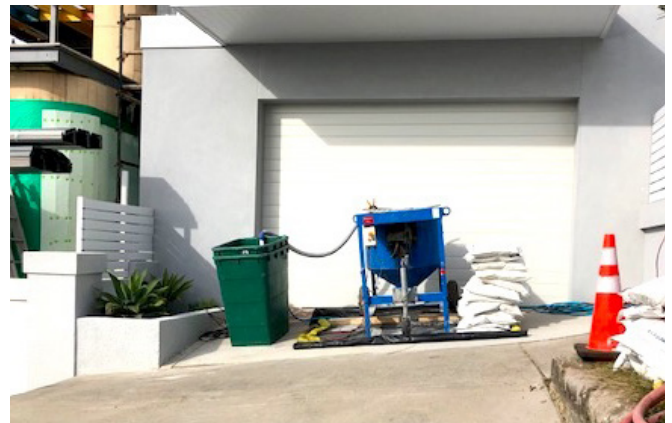
Mainmark equipment set up outside the home, with minimal disturbance and occupied space

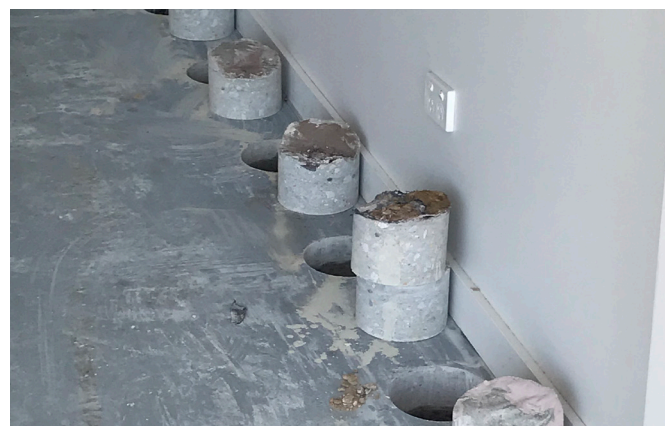
Holes prepared for injection of permeation grouting

The process of stabilising non-cohesive soils using permeation grouting involves the application of microfine cement or sodium silicate in liquid form into the ground via permeation spikes (or injection lances) at the depth to be treated, bonded and contained. This technique fills micro voids in the sand to produce a solidified mass, bonding the sand particles with the permeation grout product. The solution is often used to stabilise and strengthen sandy soils prior to excavation and building works.
