Teretek® Remediate Sydney Harbour Seawall

Harbourside apartment complex, seawall

Soil erosion and voids

Kirribilli, NSW, Australia

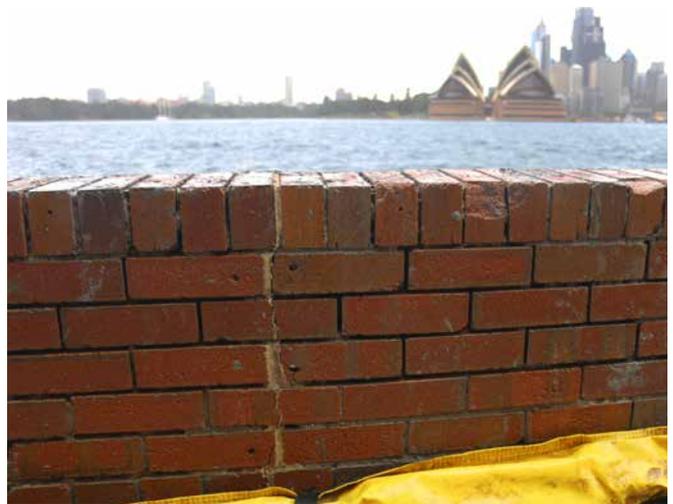
Strong southerly winds, choppy waters, and tidal currents had impacted the wall, causing a substantial amount of erosion including a washout of fines between the seawall's joints. Large cavities were identified along the seawall, with the worst affected areas at the highest and lowest tidal levels. The suction effect due to the tidal currents had also caused voids to form behind the wall, leading to the partial subsidence of a patio area facing the water's edge.

Cracks in sea wall of the property due to continuous water movement, subsidence and erosion

Mainmark recommended Teretek resin injection solution to remediate the seawall and re-level the patio. Teretek is an engineered polyurethane resin mix that, when injected into the ground, expands by chemical reaction which strengthens the ground and fills voids.

Despite the seawall's fragile state, Mainmark technicians were able to carefully inject the Teretek solution into the affected areas, which were between 2m and 3m below the edge of the patio terrace. A floating boom was placed into the water surrounding the wall to collect any waste, which could then be easily retrieved and removed without causing pollution. The contractors considered the inert Teretek engineered resin a very safe and suitable solution compared to alternative cementitious materials that would have dissipated in the water.

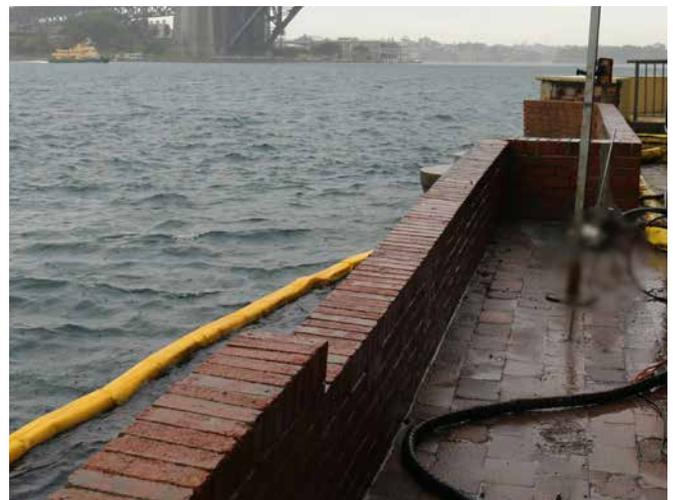
Filling the voids behind the sandstone blocks, re-supporting the seawall, and lifting and re-levelling the patio area

Teretek's easy application method and fast curing time enabled the team to complete the injection process within the very short window of time during low tide. Remediation of the 1.5m wide x 2.5m deep section of the seawall was successfully completed in one shift without the need to demolish, excavate, or rebuild the seawall. This was completed on a difficult access site by parking the Mainmark Rig at street level and injecting the resin via 80m hoses.
