Hazardous void beneath a motel swimming pool filled using cement grout

Poolside paving

Burwood, Victoria,
Australia

Mainmark Australia

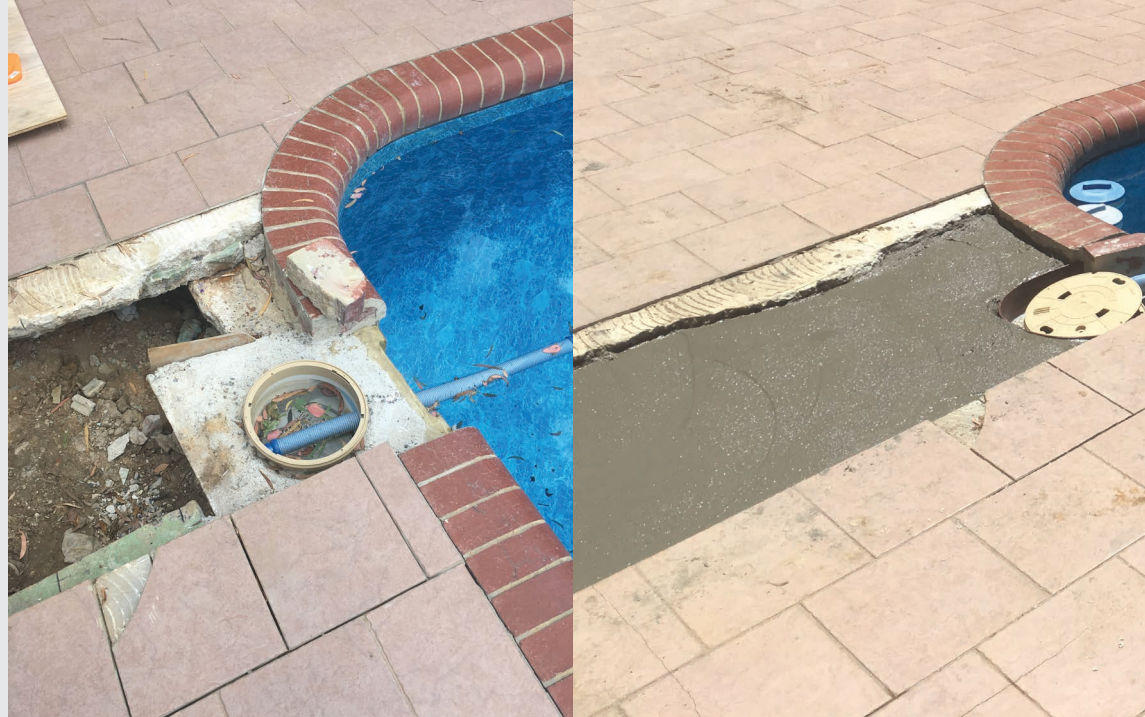
Before and after cement grout application

The Box Hill Motel, located in the eastern Melbourne suburb of Burwood, offers guests very comfortable three-and-a-half-star accommodation, including access to a large swimming pool. In December 2016, the motel operator identified a problem with pool equipment and a leak in the skimmer box was identified. As repairs were being carried out, it was discovered that the suspended slab of the pool surround had cracked and dropped, resulting in an extreme hazard.

Mainmark used a self-levelling cement grout to fill and seal the void in a single day. The placement was continuous, enabling Mainmark to fill the void quickly. The pool only needed to be closed for one day – a desirable result in the middle of a hot summer.

Mainmark pumped 8m³ of self-levelling cement grout into the void from the single access point to re-support the pool slab. Pipes were fed into the back of the void to ensure it was completely filled.
