Apartment Building Subsidence Remediated

Apartment building

Earthquake remediation

Christchurch, New Zealand

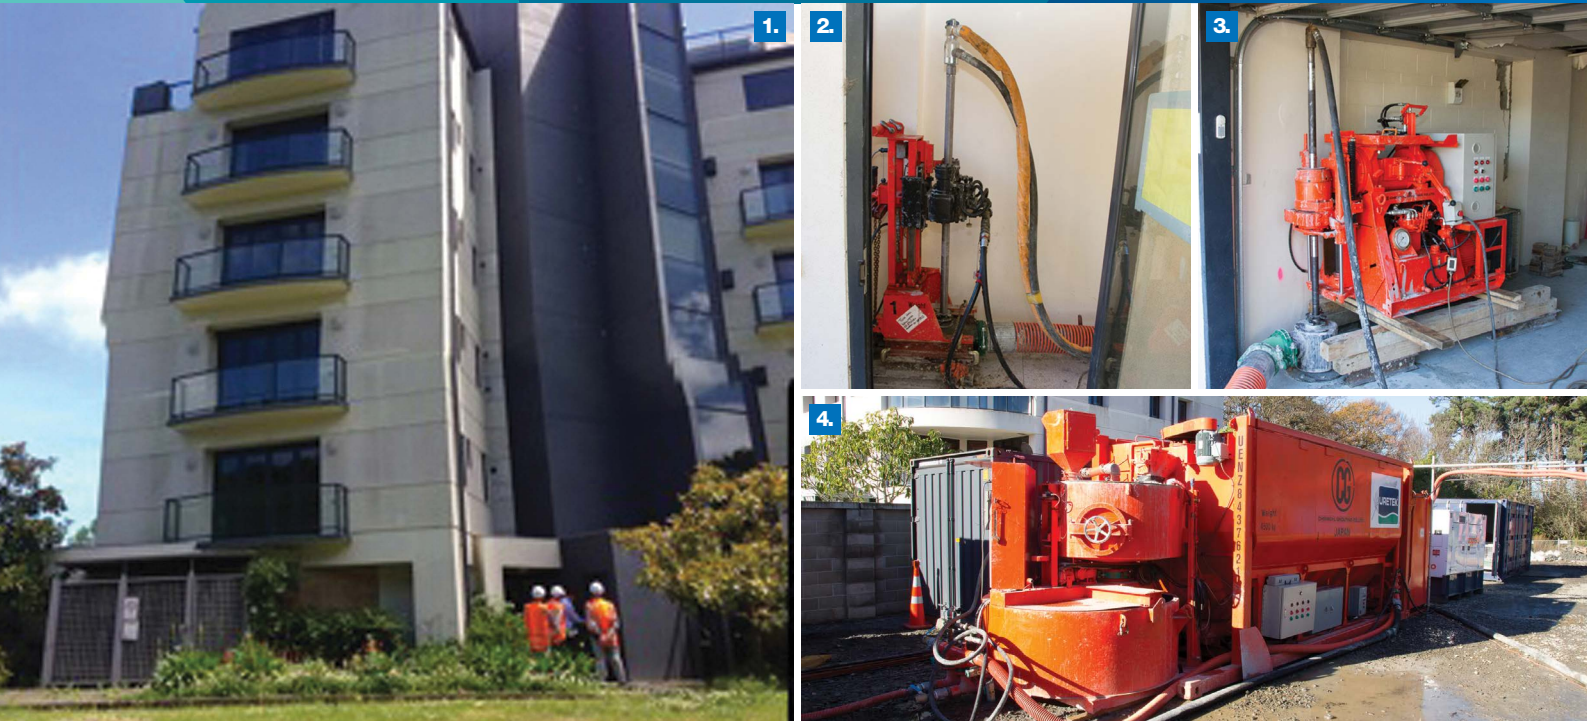
Above: 1. Technicians and engineers inspect the site. 2. Jet Grout injection from very confined spaces. 3. A larger machine Jet Grouting from a more spacious area. 4. Cement batching plant: high speed mixing equipment in front and cement silo behind. This plant can produce and deliver 24m³ of cement slurry per hour.

It was rectified using Jet Grouting to strengthen the foundation ground and by using JOG Computer-Controlled Grouting to raise the building back precisely to its design levels.

Installation of 22 Jet-Crete columns under the critical load points of the building to support and transfer loads down to the gravels. (These columns are sometimes called “soil-crete”, being a mix of cementitious grout and in-situ soil).

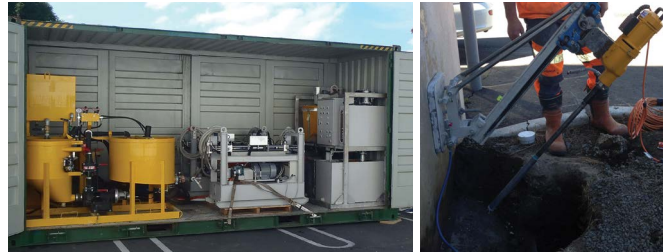
Above, left: Typical JOG site control centre with computer controls, slurry tanks and pumping equipment. Above, right: Angular insertion of JOG injector.

The computer-controlled grout levelling system was used to level the differential settlement of the structure.

20 injection ports were installed through the concrete foundations, down to the top of the Jet-Crete columns, where the high mobility grout was introduced.
