# Lift shafts stabilised for disabled access to Museum Station

Civil infrastructure (Rail)

Lift shafts

Excavation support

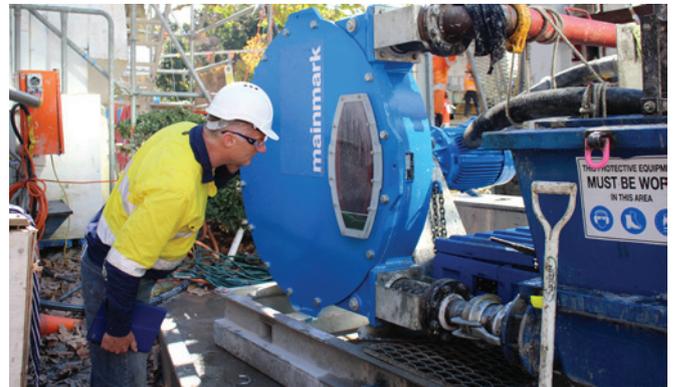
With a very congested site, the pumping operations were located between the gantry and pedestrian walkway

Additionally, Mainmark had to contend with extremely limited site access. This was due in part to the project's inner-city location. Pedestrian access to footpaths had to be maintained and vehicles could not be moved on site. The available area for pumping operations was smaller than 10 square metres while the laydown area on site was a significant distance from the lift shafts, requiring a highly-pumpable grout that could travel the distance easily.

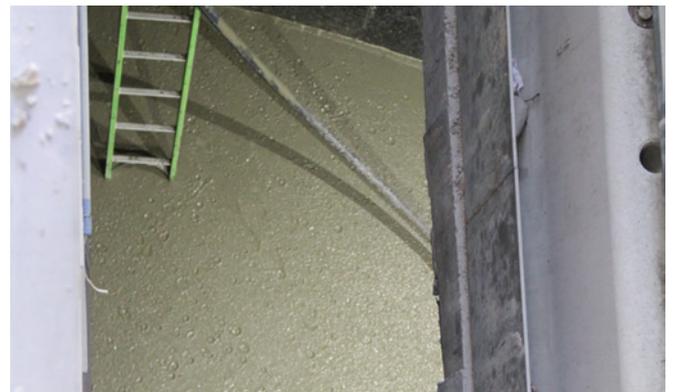
The excavation to be filled extended under Elizabeth Street

The Terefil material was used to fill a large volume, with some spaces up to three metres across. It was highly effective and successful.
