# Teretek® Remediate Sydney Harbour Seawall

Harbourside apartment complex, seawall

Soil erosion and voids

Kirribilli, NSW, Australia

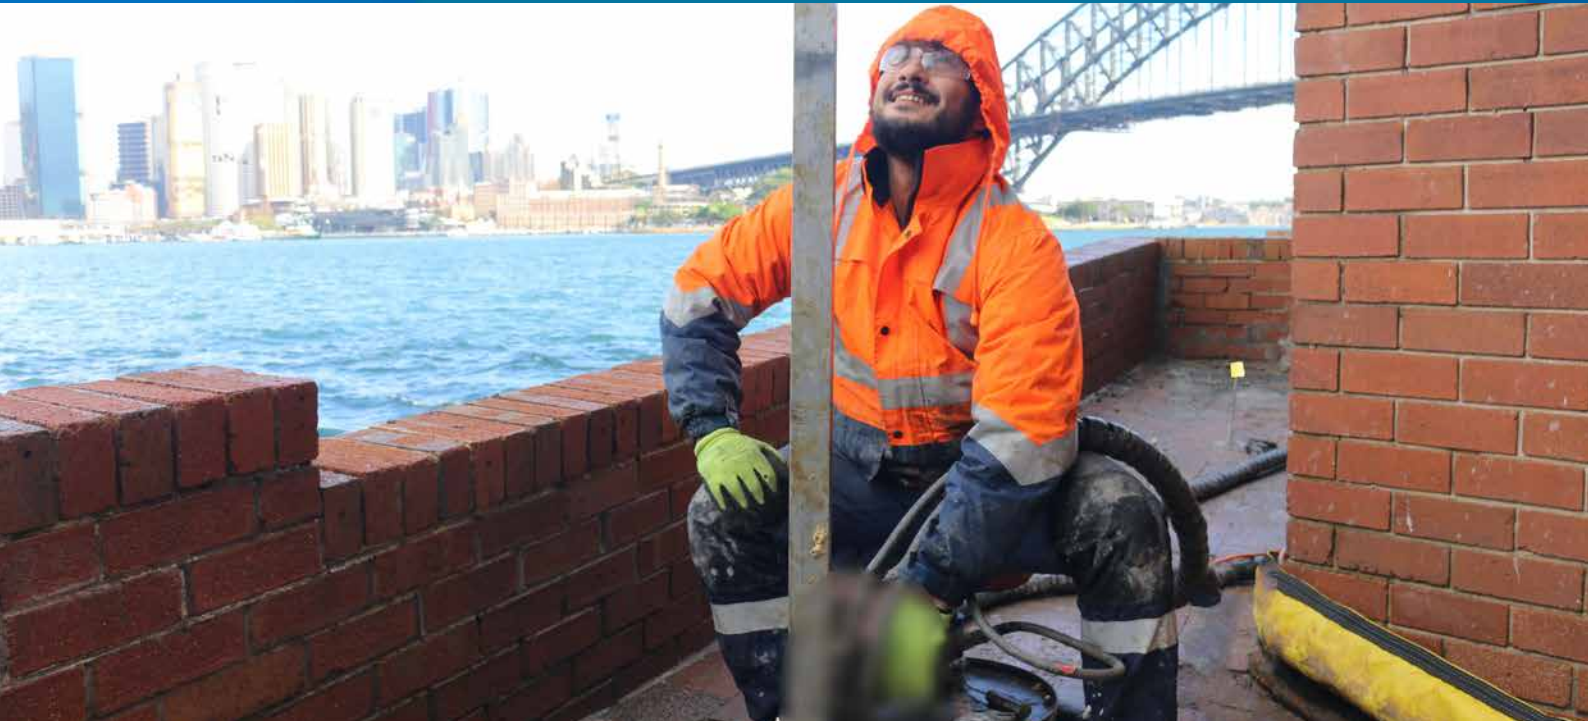
Strong southerly winds, choppy waters, and tidal currents had impacted the wall, causing a substantial amount of erosion including a washout of fines between the seawall's joints. Large cavities were identified along the seawall, with the worst affected areas at the highest and lowest tidal levels. The suction effect due to the tidal currents had also caused voids to form behind the wall, leading to the partial subsidence of a patio area facing the water's edge.

Cracks in sea wall of the property due to continuous water movement, subsidence and erosion

Mainmark recommended Teretek resin injection solution to remediate the seawall and re-level the patio. Teretek is an engineered polyurethane resin mix that, when injected into the ground, expands by chemical reaction which strengthens the ground and fills voids.

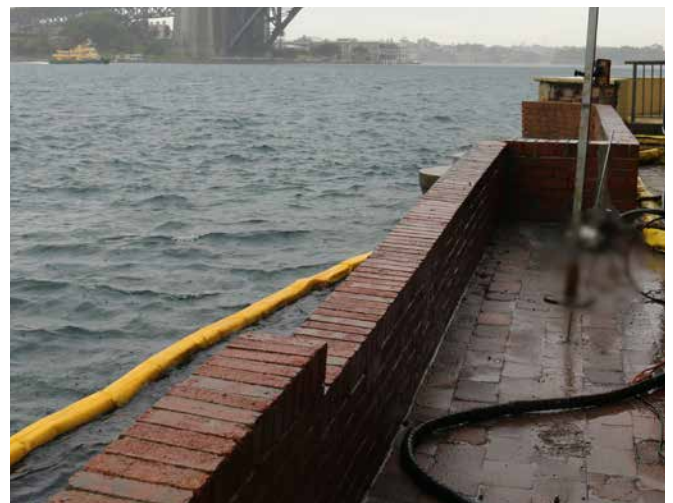
Filling the voids behind the sandstone blocks, re-supporting the seawall, and lifting and re-levelling the patio area

Despite the seawall's fragile state, Mainmark technicians were able to carefully inject the Teretek solution into the affected areas, which were between 2m and 3m below the edge of the patio terrace. A floating boom was placed into the water surrounding the wall to collect any waste, which could then be easily retrieved and removed without causing pollution. The contractors considered the inert Teretek engineered resin a very safe and suitable solution compared to alternative cementitious materials that would have dissipated in the water.

Teretek's easy application method and fast curing time enabled the team to complete the injection process within the very short window of time during low tide. Remediation of the 1.5m wide x 2.5m deep section of the seawall was successfully completed in one shift without the need to demolish, excavate, or rebuild the seawall. This was completed on a difficult access site by parking the Mainmark Rig at street level and injecting the resin via 80m hoses.
