Teretek® Fills Underwater Voids to Stabilise Kimberley Rail Bridge Piers Following Floods

PROJECT PROFILE

T18E001

Heritage railway bridge

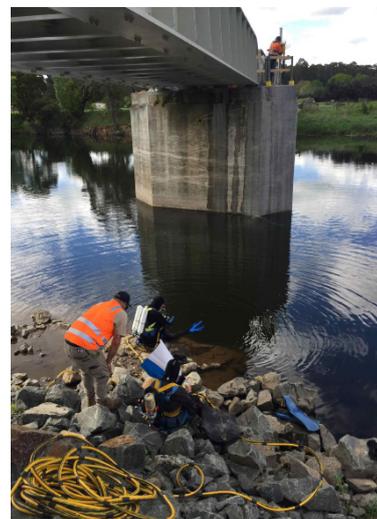
Divers preparing to inspect scour

To determine the extent of scour a carefully coordinated inspection was led by engineering consultants Pitt & Sherry, using a team of divers and a 3D sonar survey. It was determined that the riverbed had scoured away around some edges of the piers exposing the underside of the pier footing.
