# Wellington culvert rehabilitated with ENCAP6™

Culvert

Porirua, Wellington,  
New Zealand

14 days / June 2016

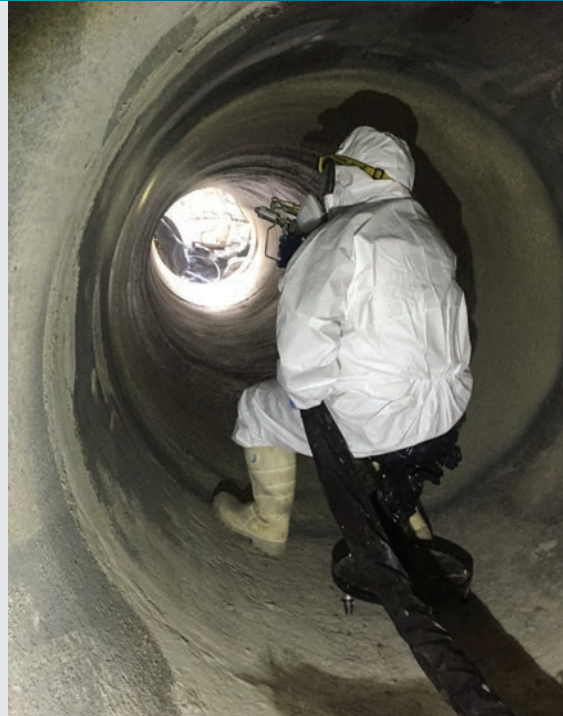
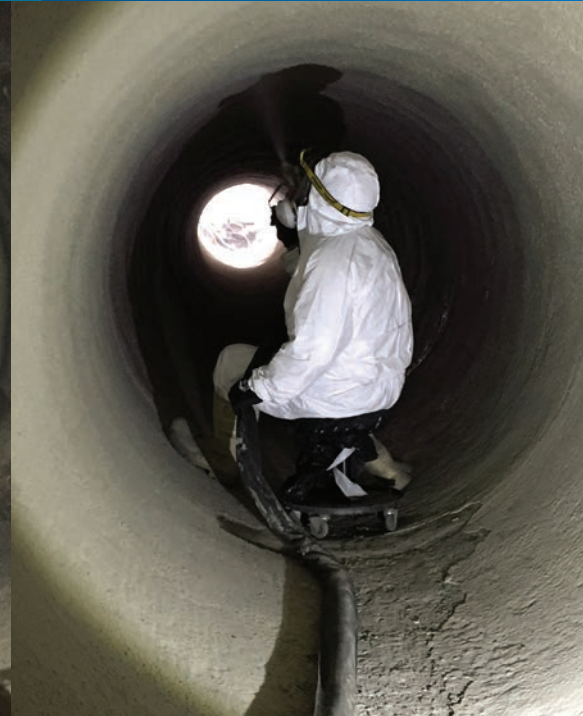
## Pictured:

Before and after ENCAP6™ application

Mainmark was commissioned to remediate a large culvert that runs under State Highway 58 near Murphy's Road, Wellington. The culvert was suffering from structural defects and pipe joint displacement due to its age.

Mainmark utilised the company's proprietary solution ENCAP6™, an innovative corrosion protection system to improve the longevity of the ageing concrete culvert.

Once the culvert was dry, Mainmark prepared the culvert by bringing it up to the required temperature and preparing its interior by sealing the joints. The ENCAP6™ solution was then applied to the culvert, which measures 1.6m in diameter and 25m in length and sits approximately 2m-3m below the busy State Highway. ENCAP6™ was sprayed in layers and built up to a thickness of 9mm.

During the remediation work, voids were discovered around the pipe which Mainmark successfully addressed using Uretek® resin.
