# Waste-water Pipeline Filled with Benefil

Pipeline

Huapai, New Zealand

Benefil

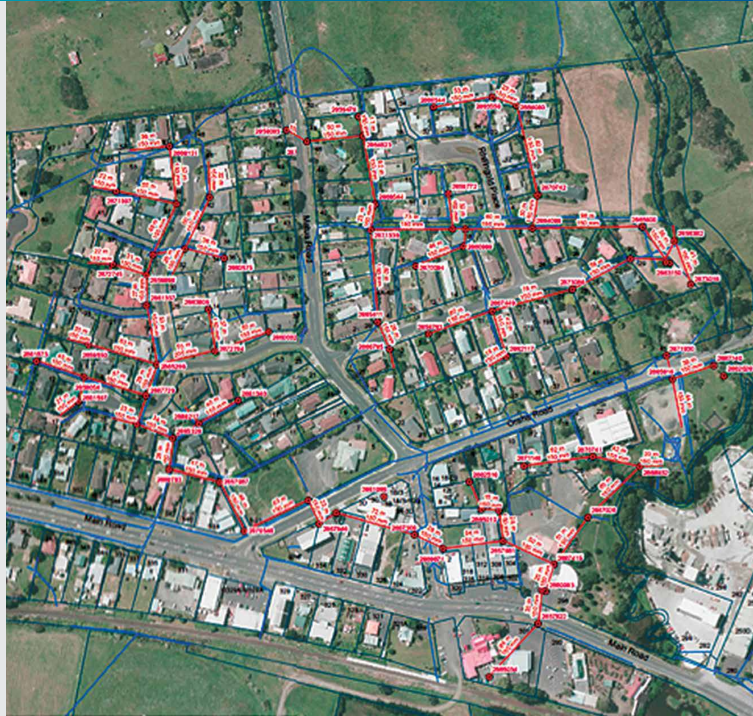
Above, left: The 3,500m of waste-water pipe-line that were filled are indicated by the blue lines. Above, right: The manholes were in roads, parks, gardens & driveways. When the pipes were filled the manholes began to fill.

Benefil amino-plastic expanding foam filler-grout was injected throughout the entire ND 150 pipeline network, access being through manholes at varying depths of up to 3m below ground.

The benefil was able to be injected easily into pipelines running both up-hill and down-hill from the injection points, which greatly facilitated rapid complete filling. The entire waste-water pipeline was filled 100% in 5 days with no excavation, access being via existing manholes. There was absolutely minimal disruption to traffic and to the residents of Huapai.
