# Teretek® Fills Voids and Re-stabilises the Soil Under a Paraparaumu Beach Home

PROJECT PROFILE

Z18W030

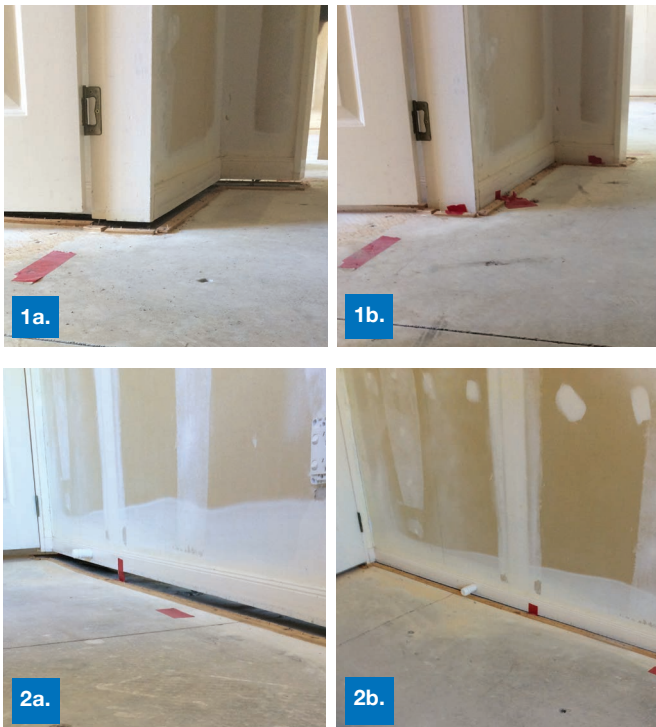
1a, 2a: Before and 1b, 2b: After Teretek® engineered resin being injected

Mainmark used its proprietary engineered resin injection solution, Teretek®, which provides a two-in-one benefit. As well as filling voids and strengthening foundation ground, Teretek also lifts and re-supports load bearing structures.

The home now sits on solid ground, the cracks have closed and the doors and windows have come back into alignment. The homeowner was amazed to see how the slab came up to meet the bottom plate of the walls when the resin was injected.
