Water Ingress in Building Basement Eliminated with Acrylic Gel

Underground Basement

Wollongong, NSW,
Australia

1 week / February 2020

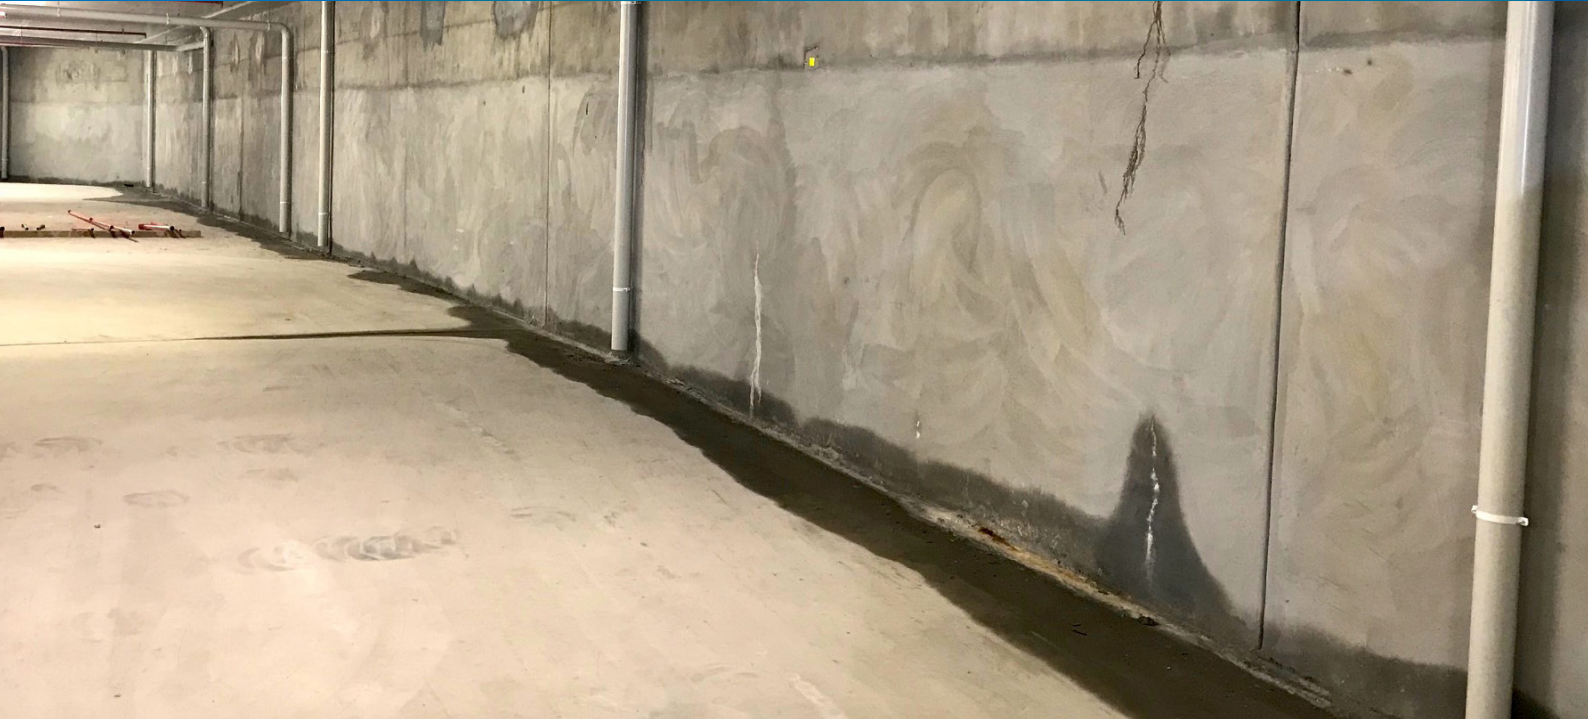
A commercial property under construction in Wollongong was experiencing water ingress in the basement, primarily caused by the high water table located approximately 2m above the basement slab.

The site was originally de-watered, however, when the de-watering system was removed after the basement construction was completed, the water ingress progressively increased. Water leakage was evident across the basement slab to the wall junction, along the lift shaft wall and other spot locations.

Mainmark's team was able to locate the source of the water, which was found to be leaking through the combination secant piled and shotcrete wall system and the basement slab. They were then able to successfully deliver a perimeter treatment that intersected the interface between the wall system and the middle of the concrete slab.

Given the time constraints and budget, Mainmark recommended using a specially formulated acrylic gel, which provided a flexible membrane and sealant between the basement concrete wall and original membrane previously installed at the rear of the basement wall.

Mainmark injected a specially formulated acrylic gel to areas where leaking was evident. The acrylic-based hydro-structural resin was identified as the most appropriate solution due to the product's ability to track the exact path of the water source, seal using a controllable reaction time, and ultra-low viscosity to seal behind the blind sides of the basement walls.
