Large Swimming Pool Re-levelled

Pool

Sinking pool

QLD, Australia

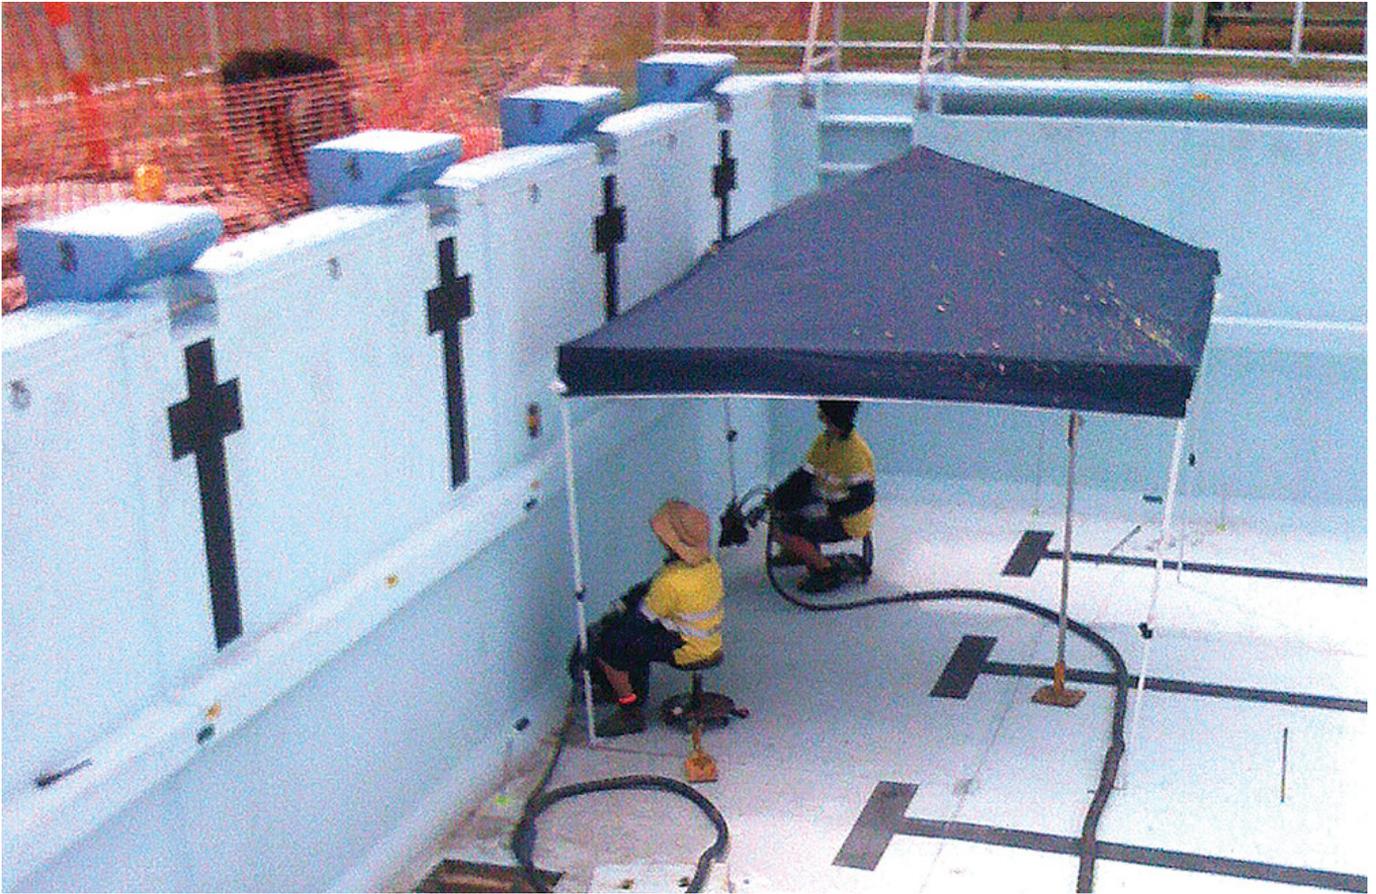
The floor joints were set down with mastic filler and vertical joints were mastic filled. The fact that the sections were pre-cast dictated a need for extremely precise and careful lifting. Over-lifting any one section could break the joint. Also, due to its large precast base, the wall could easily rotate inwards or outwards.

Additionally, as the floor slab was sitting on a step joint, the internal slab could not be lifted as this could have caused this slab to lift at the joint. This meant a slow process of lifting each precast wall section a small amount at a time to slowly bring the pool back to an acceptable level.
