# Mainmark Fills Damaged Culvert at Brisbane Airport

Following the removal of a temporary dredge pipeline that was installed in a concrete enveloper culvert beneath an operational runway, a dilapidation site inspection revealed damage to the enveloper pipe. Mainmark was contracted to complete permanent abandonment works of the 280m concrete enveloper culvert.

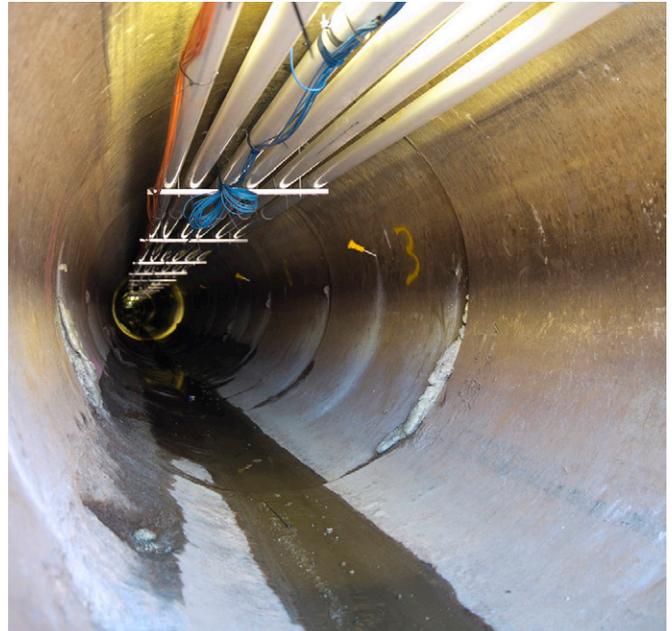
Above, top: Six 3" high pressure grouting conduits within the pipe, totalling 1,400m.

As access to the aircraft pavement was not permitted during the works, Mainmark fabricated and installed six separate three-inch high pressure grouting conduits within the culvert, totalling 1,400m. These conduits allowed grouting to be undertaken from a single access point at one end of the culvert.

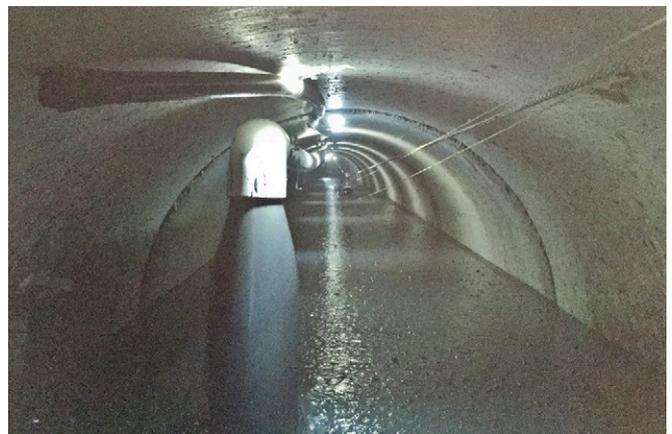
Above, middle: Video monitoring the filling of the pipe. The Terefil™ product can be seen in the foreground being pumped continuously into the pipe.

The filling operation was monitored in real time by 16 separate sacrificial cameras installed within the crown of the culvert, which ensured the culvert was completely filled, with no air pockets within the crown of the pipe.

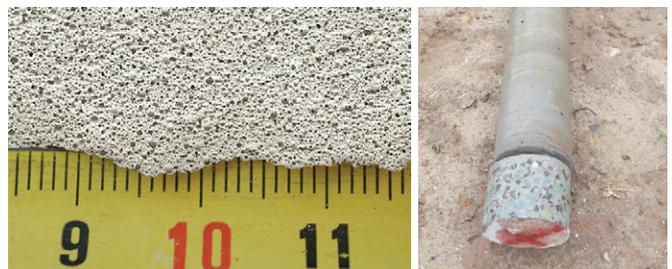
Above, left: The lightweight and uniform cell structure of Terefil™. Above, right: Mainmark coring samples taken from a test pipe showing the 100% fill and uniform strength that Terefil™ can provide.

As a highly flowable and easily placed material, Terefil™ was ideal for this project. It also does not require pre-loading or compaction for settlement mitigation, will flow into spaces to fill voids and typically exhibits shrinkage of less than 0.1%.
