# JOG and Teretek® Re-supports and Re-levels Milton Keynes Commercial Property

PROJECT PROFILE

Office Building

Subsidence

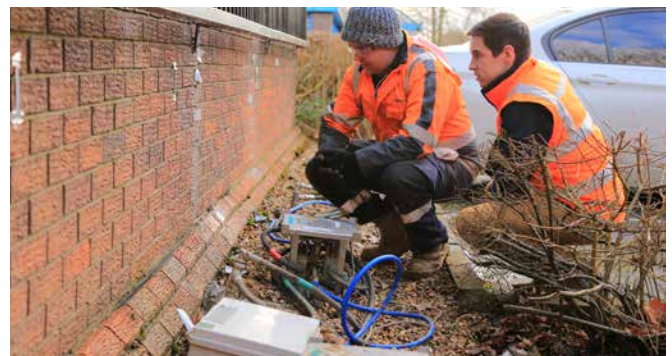
Mainmark engineers monitoring non-invasive re-levelling

Multiple injection ports were installed through the concrete foundation and structural pads along the subsided section of the building, through which the JOG high mobility cementitious grout was introduced under computer control. This enabled Mainmark to gradually and precisely lift the building in a controlled manner without causing any business interruption. The spacing and placement of the injection ports were tailored to accommodate the structural elements of the foundation, while the grout was mixed and pumped from self-contained units stationed behind the building ensuring no business interruption.

While the JOG technology raised the unit's external walls, Mainmark's proprietary Teretek resin injection solution was used to fill any voids under the internal floor slab, thus raising the floor to level with the external walls. Teretek is unique in that it delivers both ground improvement and re-levelling in a fast, non-invasive process.

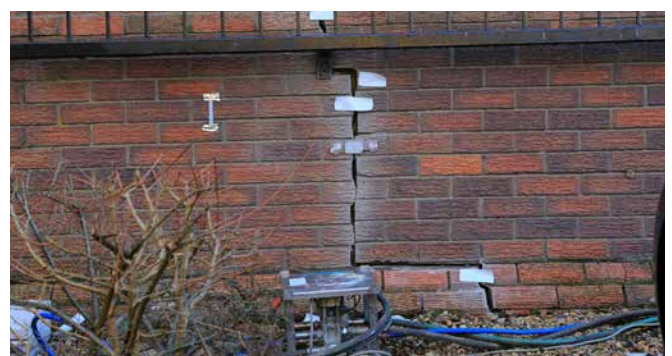
Following the record high temperatures of the summer of 2018, [MK Surveys](#), (the landlord) an independent survey and geospatial specialist, noticed the small amount of subsidence at one of its commercial office buildings in Kiln Farm, Milton Keynes, was greatly accelerating, causing significant damage to the property and external windows.

Upon inspecting the property, the Mainmark team discovered that the lowest corner of the building had subsided by 94mm and the perimeter pad foundation

had rotated outwards resulting in a discrepancy of 50mm between the internal and external levels. This required considerable care and precision when rotating the foundation pad back to horizontal, before final lifting to ensure both the external perimeter and internal flooring were raised by equivalent amounts.

External wall cracks caused by subsidence

To ensure both the internal and external foundations were equally re-levelled and correction of the rotation was achieved, Mainmark utilised two of its advanced solutions simultaneously; JOG Computer-Controlled Grouting for the main lift and re-level around the perimeter, and Teretek® resin injection for ground improvement and void filling under the internal floor slabs.

Within just seven days Mainmark raised and re-levelled the structure by 86mm, the maximum deemed appropriate without negatively impacting other factors such as the roof and internal fixtures and fittings.
