Taxiways Re-supported At Perth Airport

Sinking taxiway

Uretek Deep Injection &
Uretek Slab Lifting

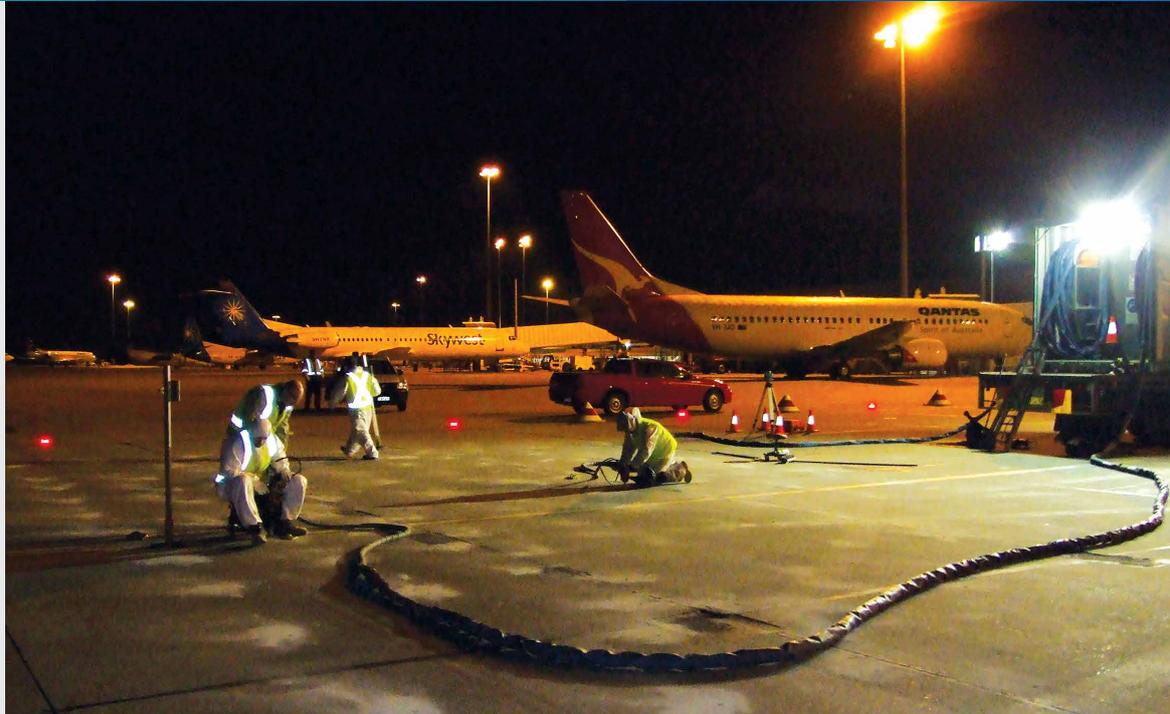
Above: In five night shifts the Operations team completed the ground compaction re-support and precision re-levelling at Perth Airport.

The slabs in these taxiway areas were pumping and cracking under the load of the aircraft when travelling at their slowest in this area as they come to a stop at the gates. In five nights the team was able to completely re-support all the slabs and ensure that they were made precisely level. This was achieved without interruption to scheduled airport operations.

The problem location involved an area of approx. 2,000m² and 900 lineal metres of joints. The slabs were 350mm thick, doweled and keyed. Poor joint seals had been allowing water ingress beneath the slabs. The construction had not been designed for today's loads.
