# Teretek® Helps West Australian Homeowner Avoid Having to Replace Wall

PROJECT PROFILE

Single-storey family home

Building footing  
subsidence, cracks in wall

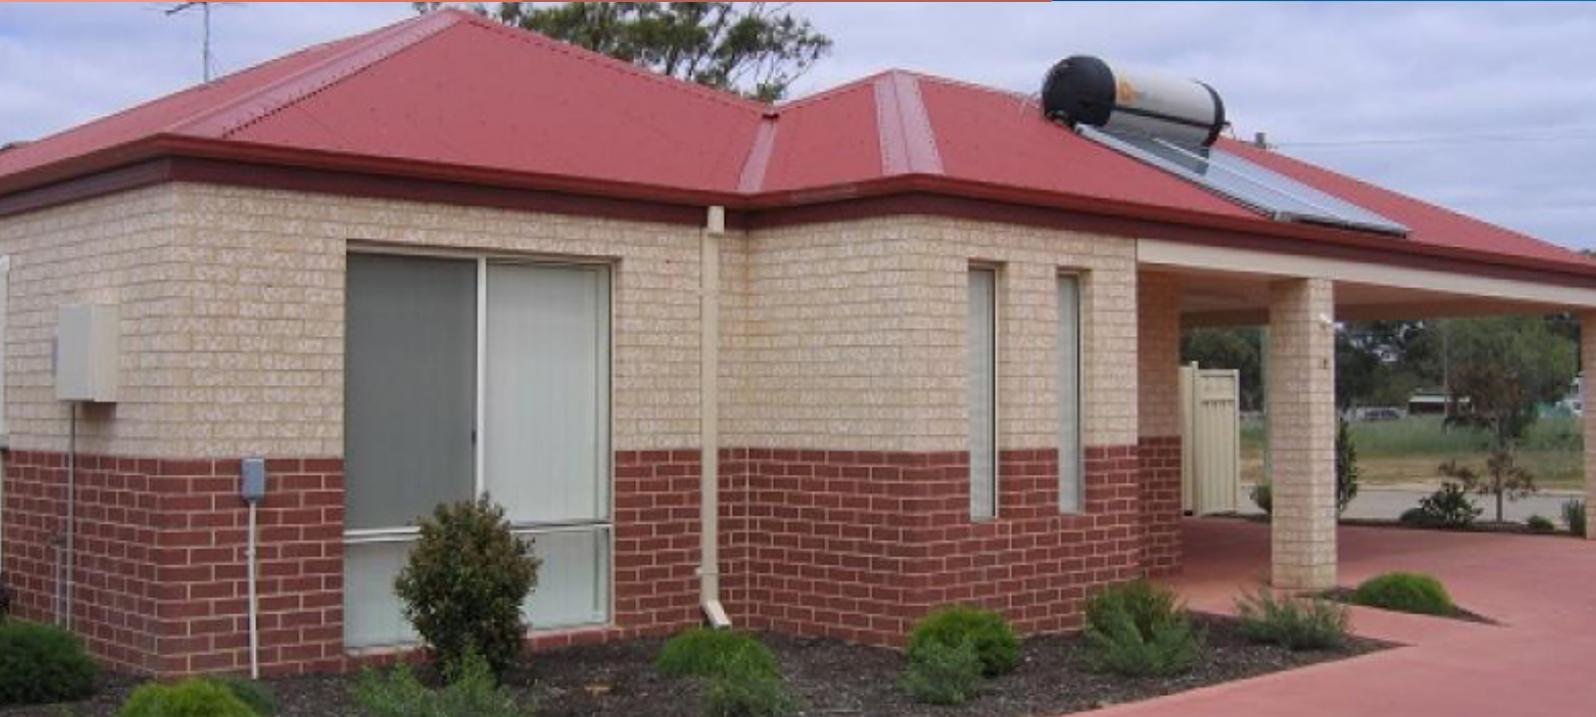
The owner of a private residence in the West Australian town of Merriden observed a large stepped crack growing in an exterior wall of an elevated corner section of the home. The crack continued to grow over a two-year period.

Mainmark assessed conditions surrounding the property and identified a leaking downpipe had caused the reactive clay soil beneath the affected section of the home to become oversaturated. The resulting ground subsidence had led the affected wall to settle by as much as 33mm along a distance of 10 lineal metres.

To help rectify the cracked wall and provide a long term solution to strengthen the ground, Mainmark recommended treating the soil beneath the affected area of the home with its proprietary engineered resin injection solution, Teretek®, to increase ground bearing capacity and reduce the risk of further subsidence.

Due to its controlled application process, Teretek avoided the risk of undue stress on the building during the lifting process. The home was gently returned back to level under the supervision of Mainmark technicians, who continually monitored the building, correcting the 33mm settlement and closing the step crack that had appeared in the wall.

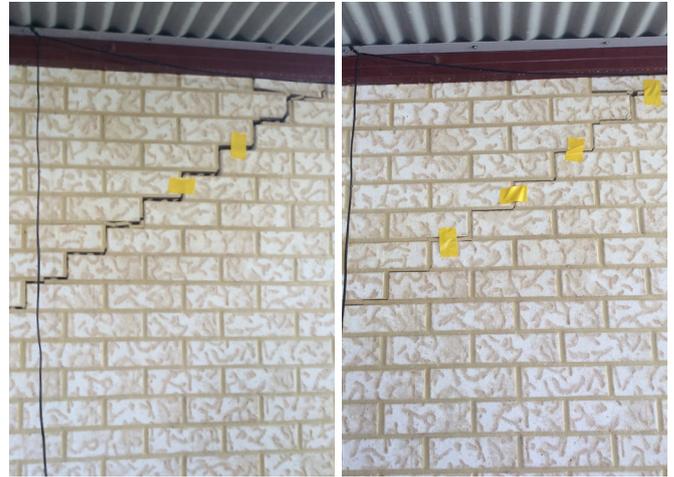
Wall cracks before and after injection of Teretek® engineered resin

In a process that is likened to keyhole surgery, Teretek engineered resin was injected 2-3 metres deep into the ground beneath the footings through 10 carefully selected points along the affected wall.

On entering the ground, the polymer resin solution quickly expands, strengthening the subsoil, filling any voids and maximising ground support to re-level the building quickly and efficiently. The process is fast, clean and unobtrusive.

Works were successfully completed within 4 hours, and the results were visible almost immediately as the cracks in the bricks began to close. The homeowner was extremely happy with the results:
