# Teretek® strengthens ground and helps preserve existing renovation work

House

Soil subsidence

Prairiewood, NSW,  
Australia

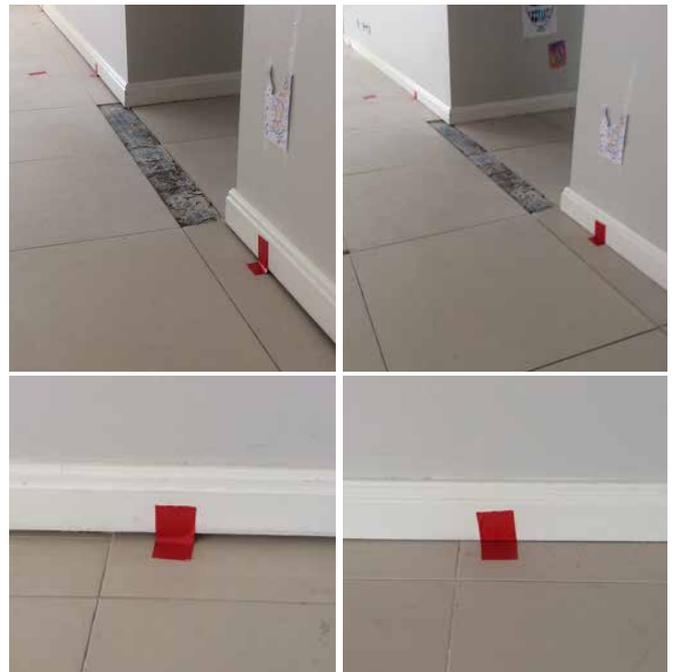
Before/after injection of Teretek® engineered resin

The internal infill slab, which was sitting on ground fill, was subsiding due to weak uncompacted soil. The laser level readings found the slab had dropped approximately 15mm which Mainmark addressed by injecting Teretek to lift the slab back to its original position.

The home's external strip footings had also suffered serious subsidence, sinking up to 38mm. However, to avoid causing further damage to the recent renovations, it was not possible to lift the footings back to their original position. Therefore, Mainmark used Teretek to improve the bearing capacity of the soil, with a minimal lift of up to 5mm, strengthening the underlying ground while preserving the completed renovation work.
