# Terefil® used to fill and decommission ageing wastewater infrastructure in New Zealand parkland

Decommissioned wastewater transmission lines

Auckland, New Zealand

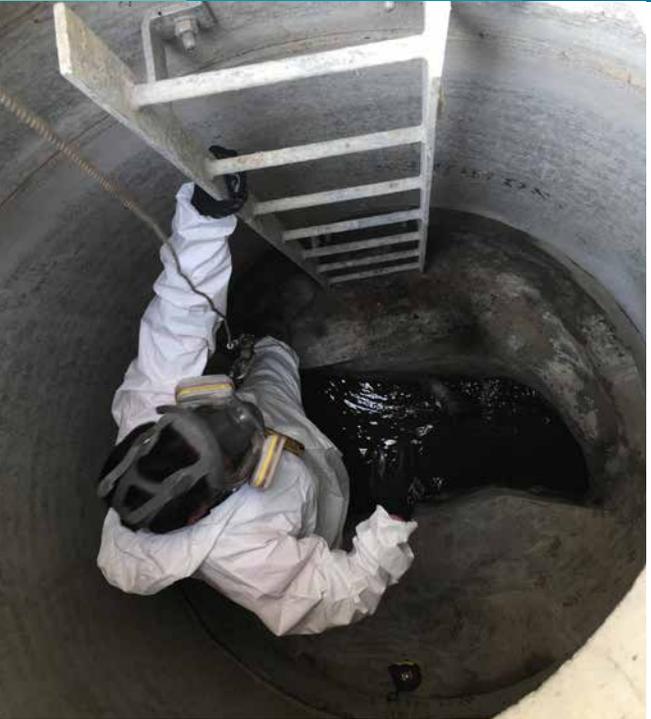
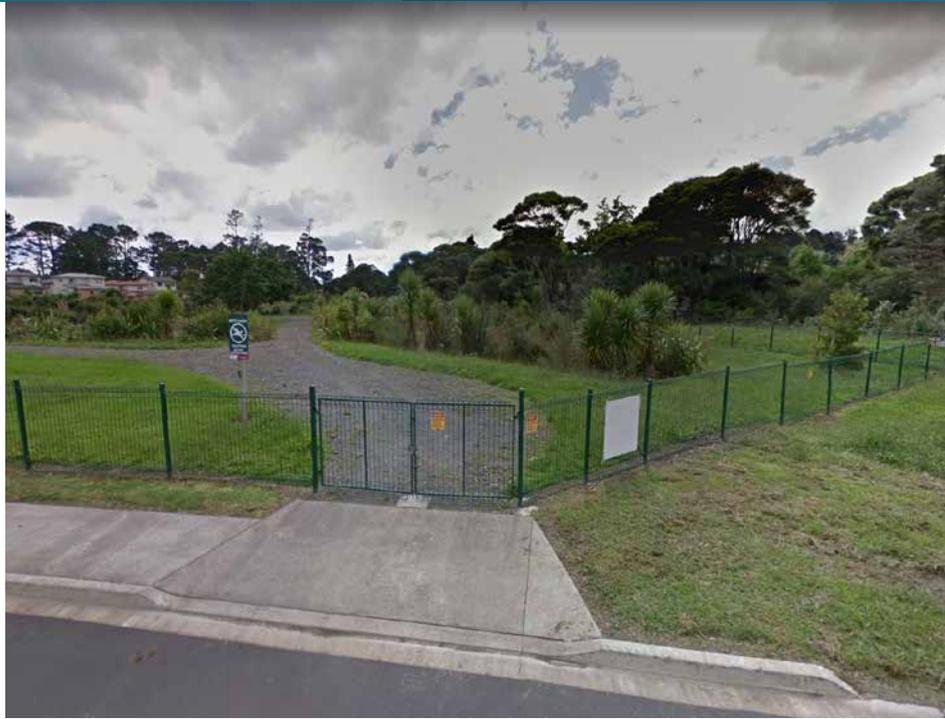
Above: (Left) The end of the ageing infrastructure was accessed from the new network. (Right) The network to be decommissioned ran through a popular public parkland that was difficult for vehicles or machinery to access.

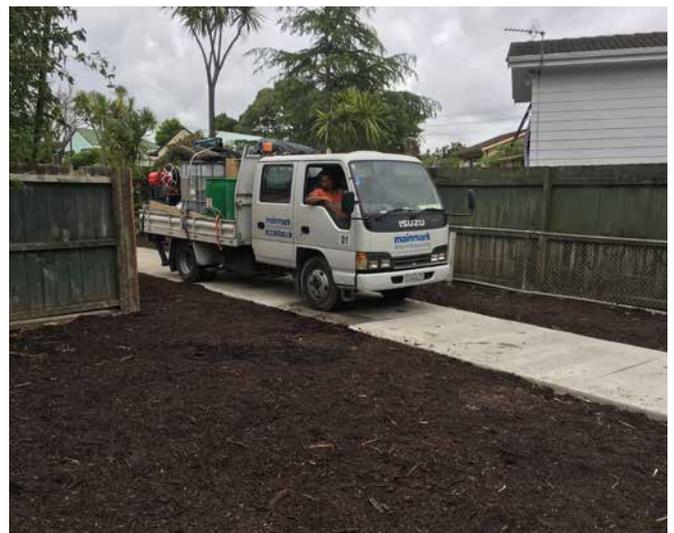
Access to pumping locations was limited so Mainmark planned carefully to avoid significant disruption to the public parkland.
