JOG Corrects Slab Dishing in Large Transport Yard

Transport yard hardstand

Subsidence

JOG Computer-Controlled Grouting

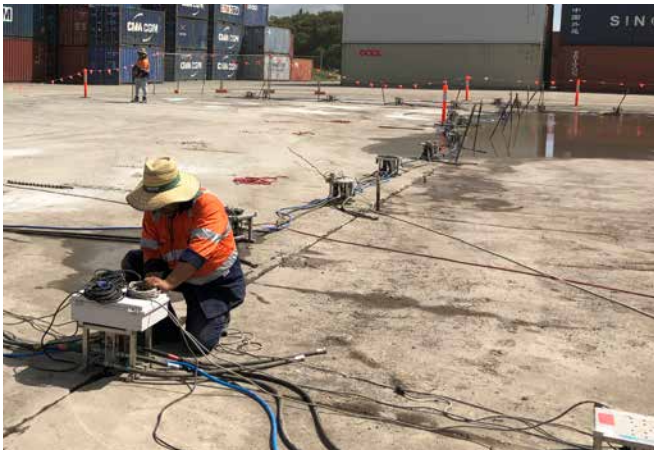
Due to the high water-table, the substrate beneath the slab consists of soft marine mud, approximately 23m deep, that is continually affected by daily tidal flows. This issue has been exacerbated by failing joint seals between the concrete slabs that allowed additional water ingress to affect the soil substrate beneath the slab. As slab settlement continued to occur, the outer edges of the hardstand sat higher than the midline (known as dishing), which caused water to pool in the centre further compounding the problem.

SEQH needed to find a solution to remove dishing and water pooling along the hardstand's midline (seen in the background)

JOG Computer-Controlled Grouting (JOG) was selected as the ideal method for correcting the hardstand area. The highly precise process using computer-controlled injection technology and fast setting grout is ideal for correcting large areas and heavy structures, gradually and gently lifting them back to level.

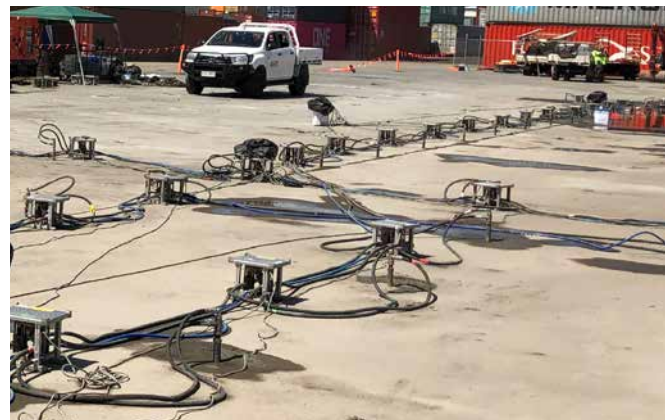
Mainmark installed a total of 400 JOG injection points.

Mainmark re-levelled the hardstand by installing JOG grout delivery ports along the strengthening beams running under the slab construction joints. A total of 400 injection points were installed at 2.5m centres and 5m centres along the strengthening beam and across the slab area in a grid pattern.

JOG is delivered through sequenced injection points, each controlled from advanced grout monitors, to achieve a high degree of injection accuracy. Despite the immense size of the hardstand area, Mainmark technicians controlled the lift in increments less than 0.5mm across sections of up to 700m² at a time. This resulted in an overall lift to the hardstand's centreline of 120mm, improving the gradient by 20mm causing the water to drain away from the centre.
