# Terefil® Used to Fill and Decommission Ageing Wastewater Infrastructure in New Zealand Parkland

INDUSTRY	Infrastructure
STRUCTURE	Decommissioned wastewater transmission lines
PROBLEM	Fill abandoned pipes
LOCATION	Auckland, New Zealand
DURATION / YEAR	5 days / January 2018
TECHNOLOGY	Terefil®
BUSINESS UNIT	Mainmark New Zealand

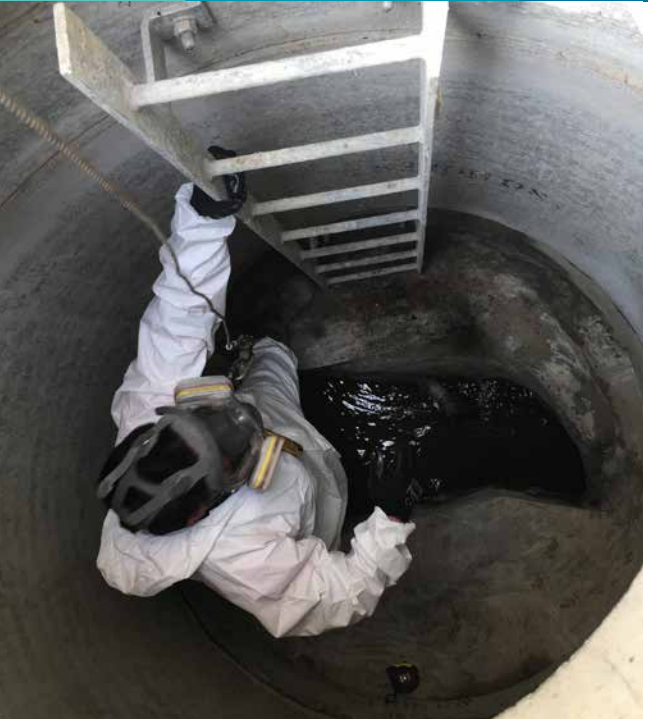
Above: (Left) The end of the ageing infrastructure was accessed from the new network. (Right) The network to be decommissioned ran through a popular public parkland that was difficult for vehicles or machinery to access.
