# Earthquake Damaged Home Re-Levelled Using Teretek® and JOG Computer Controlled Grouting

PROJECT PROFILE

Y20RV048

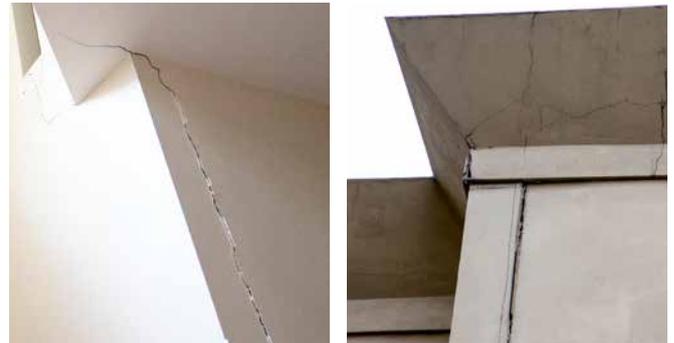
Large crackings in internal and external walls of the house due to differential settlement

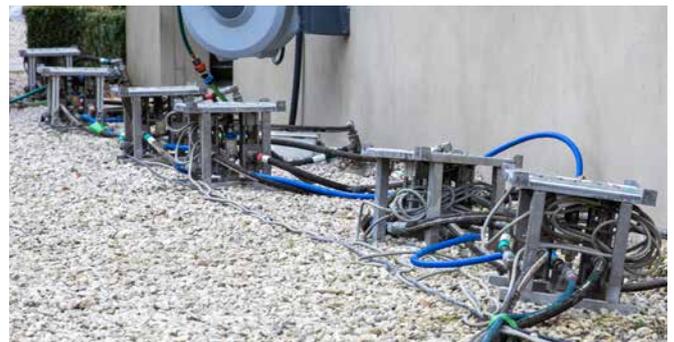
JOG Androids placed along the outside the house

Mainmark's JOG Computer-Controlled Grouting was identified as an ideal solution to re-level the heavy, 550m<sup>2</sup> concrete home. JOG uses a precise and non-invasive application technique to carefully raise the home's footings back to level. The cementitious grout injection process has been used extensively in New Zealand and Japan to remediate large earthquake-damaged structures.

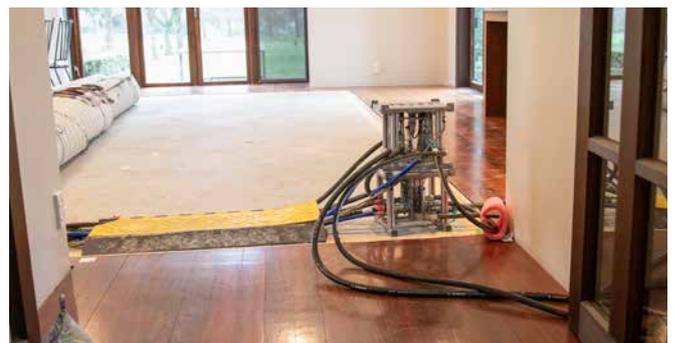
JOG Androids placed inside the house with minimal disturbance to the homeowners and without the need to demolish the property
