Commercial Building Subsidence Remediated

Office building

Earthquake remediation

Christchurch New Zealand

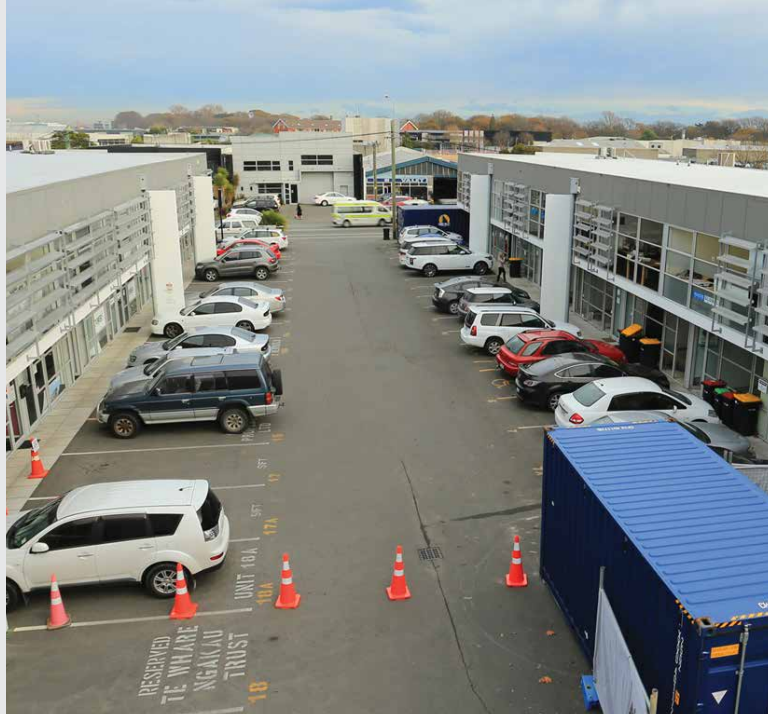
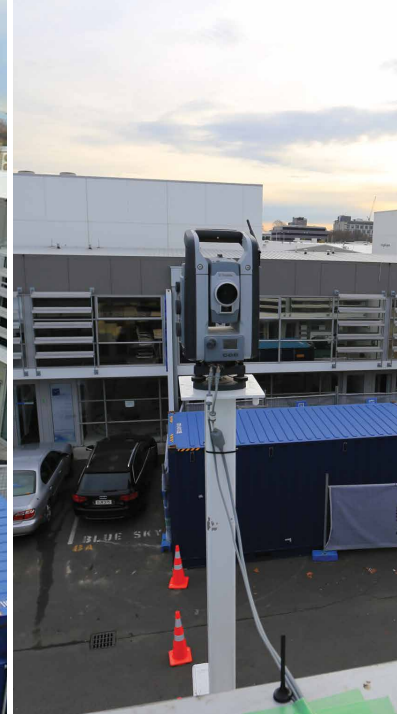
A building in this commercial complex of ten units in Christchurch had suffered differential settlement of up to 178mm with the 2010-2011 earthquakes.

74 JOG injection ports were installed through the concrete foundations, where the high mobility grout was introduced. The maximum lift was 178mm and the average was 110mm.

The JOG Computer-Controlled Grouting levelling system was used to level the tilted, differential settlement of the structure. The fine degree of control offered by JOG allowed the substantial lift of the building to not affect the adjacent property.

Robotic survey stations were established above the other building of the complex to pick up level data from the many survey prisms set up on the building being lifted.

The structure was re-levelled successfully, returning the building to design levels, while leaving the neighbouring property unaffected.
