# Ground strengthened and building re-levelled at large shopping centre

PROJECT PROFILE

Z15Y036

Shopping Centre

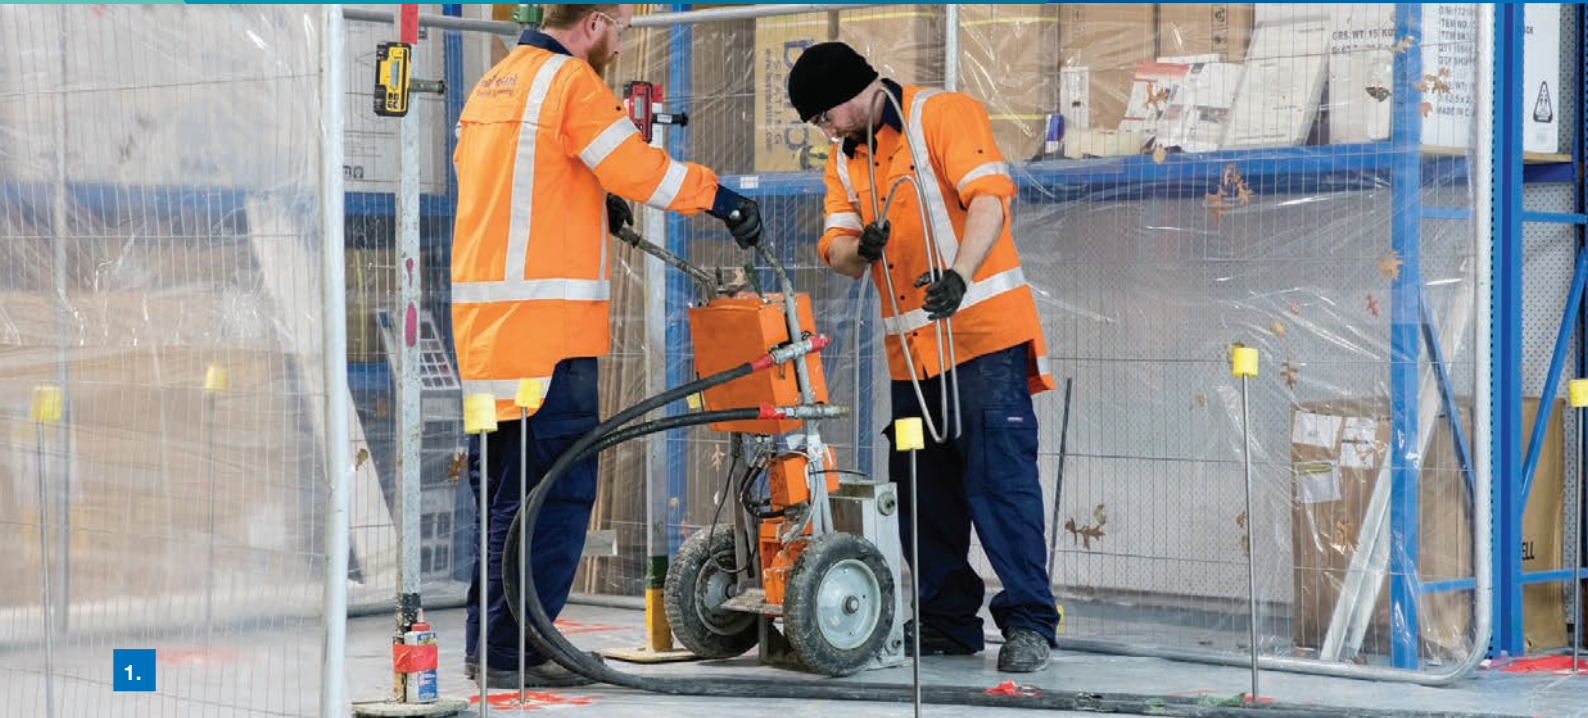
Pictured above:  
1. Keyhole Liquefaction  
Mitigation delivery in  
progress.

Mainmark's Liquefaction Mitigation offering is the only solution of its kind and can be applied retrospectively beneath existing buildings or structures. The ground beneath the Northwood Supa Centa was treated via more than 3,000 injection points to a depth of between 4m to 8m below ground level, and across the building's footprint.

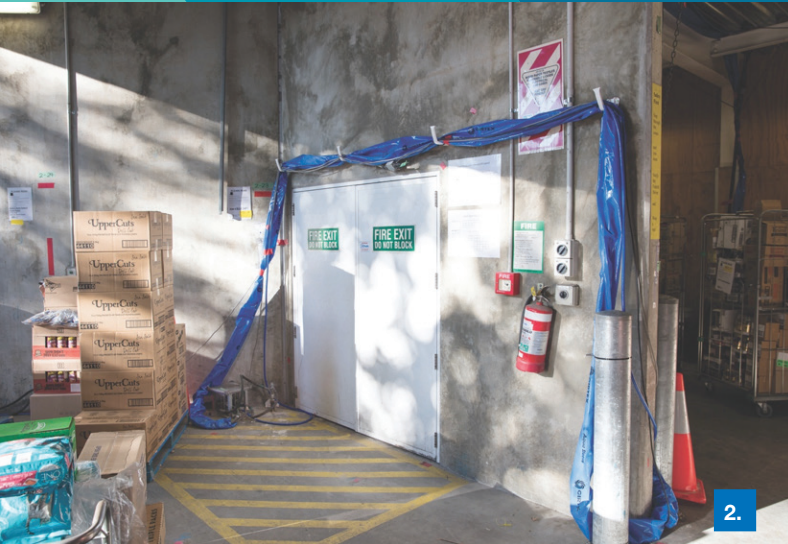
2. Customised installation of required hoses and cables allowed tenants to remain fully operational during the project without compromising health and safety. 3. Internal injection works carried out at night; full store operations restored by opening everyday.
