Operational petrol station re-levelled with Uretex®

Service Station

Ground Subsidence

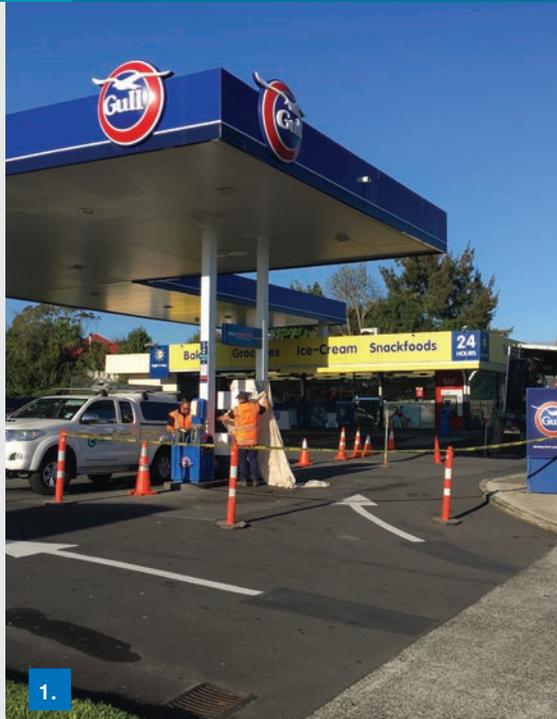
1. Gull service station
2. Drain sump sunk along with fill around leaving voids beneath the slab
3. Slab after injection

Mainmark successfully re-levelled and re-supported the forecourt in just three hours and with minimal disruption, allowing the service station to continue operations safely.

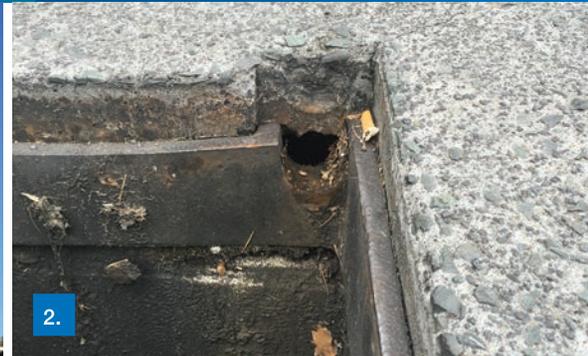
A site inspection found voids of up to 100mm beneath the forecourt, indicating it had lost integral structural support. The sunken forecourt was at risk of collapse under the weight of regular deliveries from 50 tonne petrol tankers, which could have catastrophic consequences.

Mainmark used its patented structural resin injection technology, Uretex®, to fill the voids and re-support the existing slab.

Small holes were drilled into the ground below the slab and the expanding structural resins were injected. On entering the ground, the components mixed together and expanded by chemical reaction to fill voids and cavities in the soil to form a strong base.
