# Terefil® Used to Fill and Decommission Ageing Wastewater Infrastructure in New Zealand Parkland

Decommissioned wastewater transmission lines

Auckland, New Zealand

Mainmark New Zealand

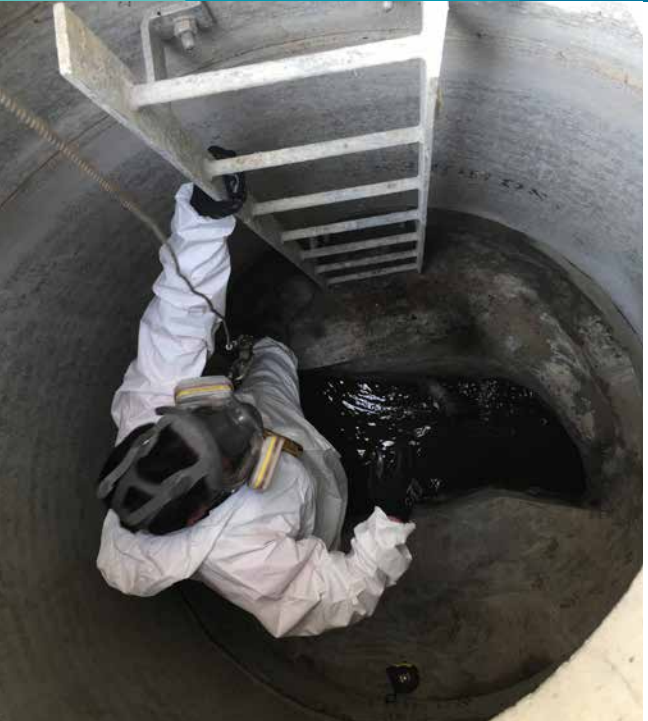
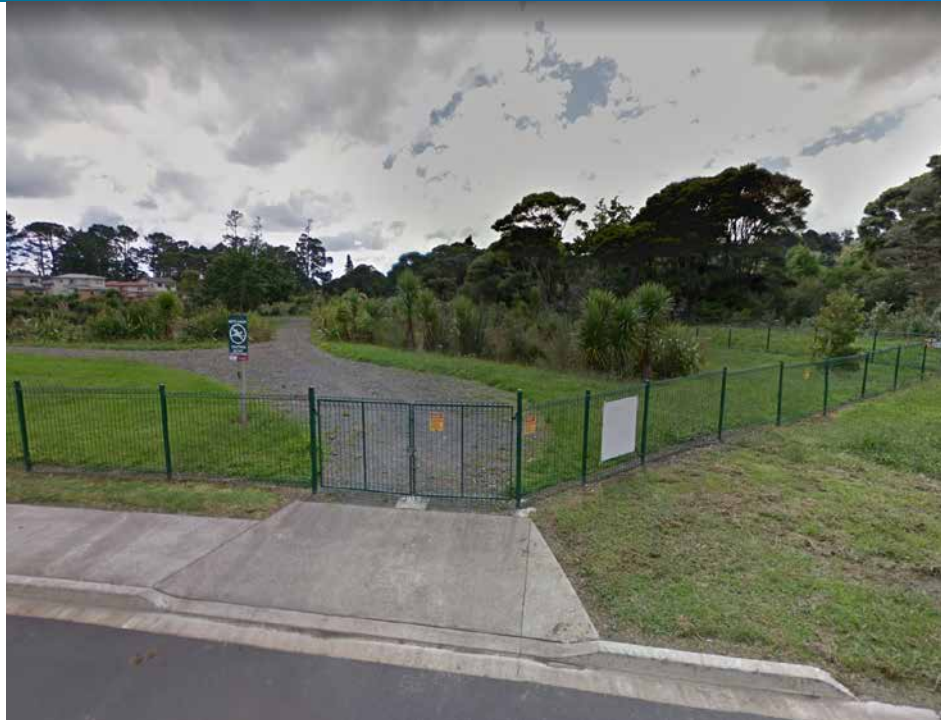
Above: (Left) The end of the ageing infrastructure was accessed from the new network. (Right) The network to be decommissioned ran through a popular public parkland that was difficult for vehicles or machinery to access.

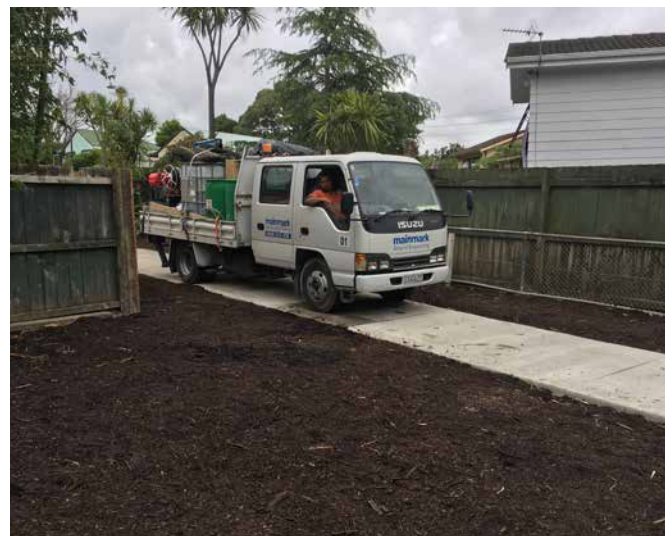
Access to pumping locations was limited so Mainmark planned carefully to avoid significant disruption to the public parkland.
